General Information

Make	Suzuki	Model	Ertiga
YOM	2024	Odo Meter Reading	21,921
Registration No.	NOV2215	Chassis No.	MHYNC32S9RJ106950
CC	1.5	Transmission	A/T
Fuel Type	Hybrid	Type of Body	Wagon
Colour	Red

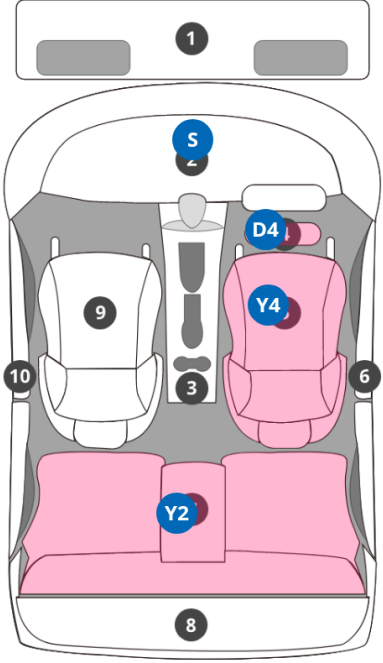
Interior Evaluation : C	Exterior Evaluation : E

<p>a : Cut, Fray d : Loose, Deformed k : Animal Hair s : Smell t : Cigarette Burns x : Defective y : Stain</p>

<p>A : Scratch AU : Scratch & Dent B : Modified C : Corrosion G : Stone chip P : Faded S : Rust SC : Rust & Corrosion U : Dent X : Defective Y : Crack, Gap</p>
<p>Remarks Overall Interior - Smell - Yes / Rear Seat - Grime - Small / (R) Front Seat - Grime - Large / (L) Front Floor Mat - Worked - Large</p>	<p>Remarks Front Bumper, Grille, Lamps - Scratch & Dent - Large / (R) Front Fender, Molding - Scratch - Medium / (R) Front Door, Molding - Scratch - Large / (R) Rear Door, Molding - Scratch & Dent - Large / (R) Rear Fender, Molding - Scratch & Dent - Large / Rear Bumper, Lamps, Panels - Scratch - Large / Trunk Hood, Rear Gate - Dent - Small / (L) Rear Fender, Molding - Scratch - Small / (L) Rear Door, Molding - Scratch & Dent - Small / (L) Front Door, Molding - Scratch & Dent - Small / (L) Front Fender, Molding - Scratch - Small / Bonnet, Headlight - Scratch - Small</p>
