General Information

Make	Toyota	Model	Vios
YOM	2025	Odo Meter Reading	12,286
Registration No.	NEY6537	Chassis No.	PA1B18F30R4264044
CC	1.3	Transmission	CVT
Fuel Type	Gas	Type of Body	Sedan
Colour	Red Mica Metallic

Body / Panel Condition

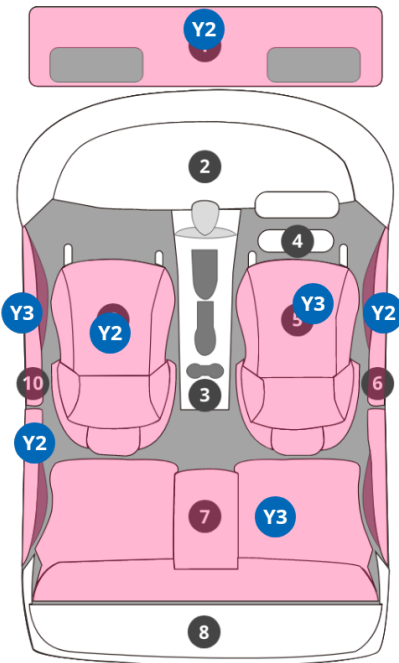
Interior Evaluation : C	Exterior Evaluation : E

<p>a : Cut, Fray d : Loose, Deformed k : Animal Hair s : Smell t : Cigarette Burns x : Defective y : Stain</p>

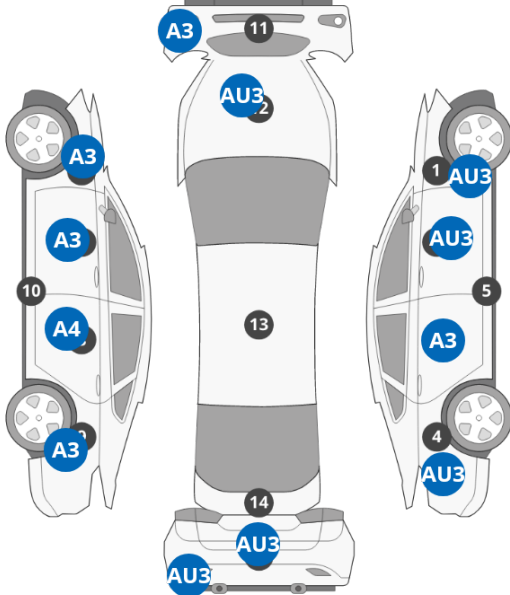
<p>A : Scratch AU : Scratch & Dent B : Modified C : Corrosion G : Stone chip P : Faded S : Rust SC : Rust & Corrosion U : Dent X : Defective Y : Crack, Gap</p>
<p>Remarks (R) Front Seat - Grime - Medium / (R) Front Trim - Grime - Small / Rear Seat - Grime - Medium / (L) Rear Trim - Grime - Small / (L) Front Trim - Grime - Medium / (L) Front Seat - Grime - Small / Ceiling - Grime - Small</p>	<p>Remarks (L) Rear Door, Molding - Scratch - Large / (L) Front Door, Molding - Scratch - Medium / (L) Front Fender, Molding - Scratch - Medium / (L) Rear Fender, Molding - Scratch - Medium / Rear Bumper, Lamps, Panels - Scratch & Dent - Medium / Trunk Hood, Rear Gate - Scratch & Dent - Medium / (R) Rear Fender, Molding - Scratch & Dent - Medium / (R) Rear Door, Molding - Scratch - Medium / (R) Front Door, Molding - Scratch & Dent - Medium / (R) Front Fender, Molding - Scratch & Dent - Medium / Bonnet, Headlight - Scratch & Dent - Medium / Front Bumper, Grille, Lamps - Scratch - Medium</p>
