General Information

Make	Toyota	Model	Innova
YOM	2024	Odo Meter Reading	11,977
Registration No.	NFR1836	Chassis No.	PA2JA8EMXR0139349
CC	2.8	Transmission	A/T
Fuel Type	Diesel	Type of Body	Wagon
Colour	Black

Body / Panel Condition

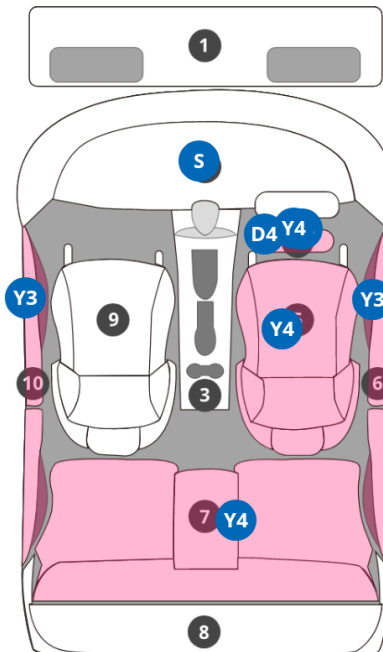
Interior Evaluation : E	Exterior Evaluation : E

<p>a : Cut, Fray d : Loose, Deformed k : Animal Hair s : Smell t : Cigarette Burns x : Defective y : Stain</p>

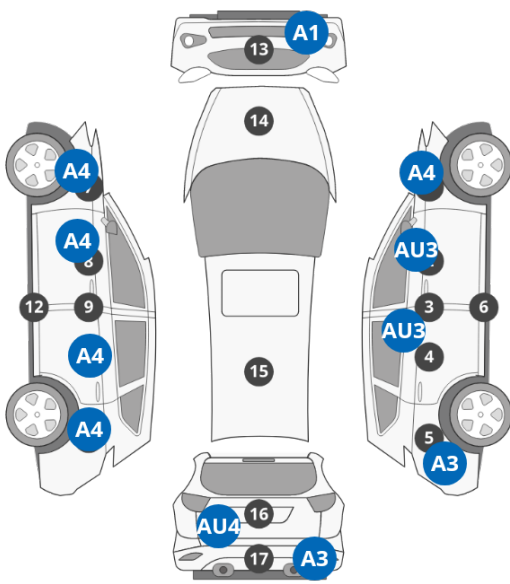
<p>A : Scratch AU : Scratch & Dent B : Modified C : Corrosion G : Stone chip P : Faded S : Rust SC : Rust & Corrosion U : Dent X : Defective Y : Crack, Gap</p>
<p>Remarks Rear Seat - Grime - Large / Mat Other - Grime - Large / (R) Front Seat - Grime - Large / (R) Front Trim - Grime - Medium / (L) Front Trim - Grime - Medium / (R) Front Floor Mat - Grime - Large / (L) Front Floor Mat - Worked - Large / Overall Interior - Smell - Yes</p>	<p>Remarks (L) Front Fender, Molding - Scratch - Large / (L) Front Door, Molding - Scratch - Large / (L) Rear Door, Molding - Scratch - Large / (L) Rear Fender, Molding - Scratch - Large / Trunk Hood, Rear Gate - Scratch & Dent - Large / Rear Bumper, Lamps, Panels - Scratch - Medium / (R) Rear Fender, Molding - Scratch - Medium / (R) Rear Door, Molding - Scratch & Dent - Medium / (R) Front Door, Molding - Scratch & Dent - Medium / (R) Front Fender, Molding - Scratch - Large / Front Bumper, Grille, Lamps - Scratch - Minimal</p>
