General Information

Make	Toyota	Model	Vios
YOM	2024	Odo Meter Reading	4,661
Registration No.	NFS5758	Chassis No.	PA1B18F36R4242551
CC	1.3	Transmission	CVT
Fuel Type	Gas	Type of Body	Sedan
Colour	Green

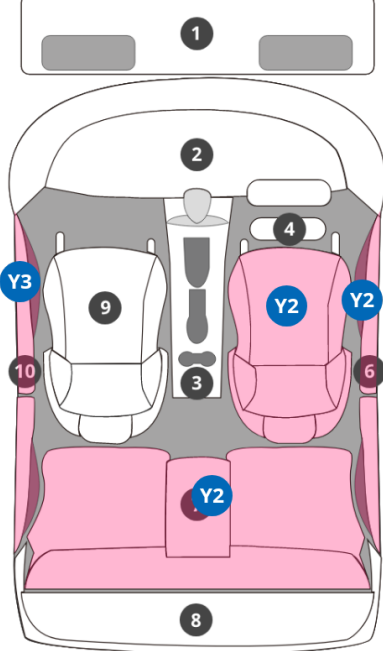
Interior Evaluation : B	Exterior Evaluation : D

<p>a : Cut, Fray d : Loose, Deformed k : Animal Hair s : Smell t : Cigarette Burns x : Defective y : Stain</p>

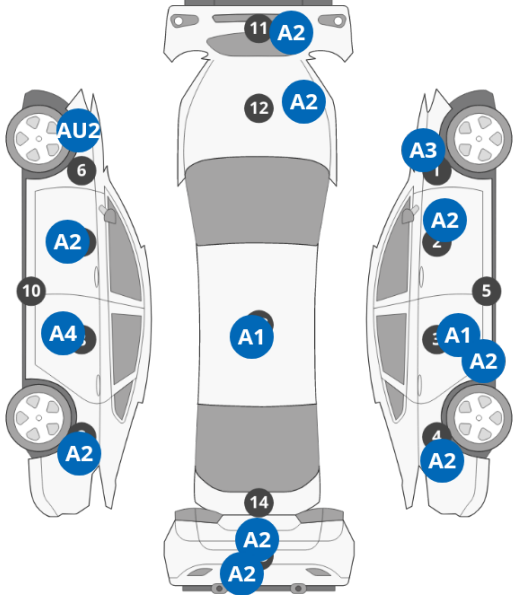
<p>A : Scratch AU : Scratch & Dent B : Modified C : Corrosion G : Stone chip P : Faded S : Rust SC : Rust & Corrosion U : Dent X : Defective Y : Crack, Gap</p>
<p>Remarks (R) Front Seat - Grime - Small / (R) Front Trim - Grime - Small / Rear Seat - Grime - Small / (L) Front Trim - Grime - Medium</p>	<p>Remarks (L) Front Fender, Molding - Scratch & Dent - Small / Bonnet, Headlight - Scratch - Small / (R) Front Fender, Molding - Scratch - Medium / (R) Front Door, Molding - Scratch - Small / (R) Rear Door, Molding - Scratch - Minimal / (R) Rear Fender, Molding - Scratch - Small / Trunk Hood, Rear Gate - Scratch - Small / Rear Bumper, Lamps, Panels - Scratch - Small / (L) Rear Fender, Molding - Scratch - Small / Roof - Scratch - Minimal / (L) Rear Door, Molding - Scratch - Large / (L) Front Door, Molding - Scratch - Small / (R) Step, In-panel, Side Spoiler - Scratch - Small / Front Bumper, Grille, Lamps - Scratch - Small</p>
