General Information

Make	Toyota	Model	Vios
YOM	2024	Odo Meter Reading	23,645
Registration No.	NHM1808	Chassis No.	PA1B18F3XP4236751
CC	1.3	Transmission	CVT
Fuel Type	Gas	Type of Body	Sedan
Colour	Blue

Body / Panel Condition

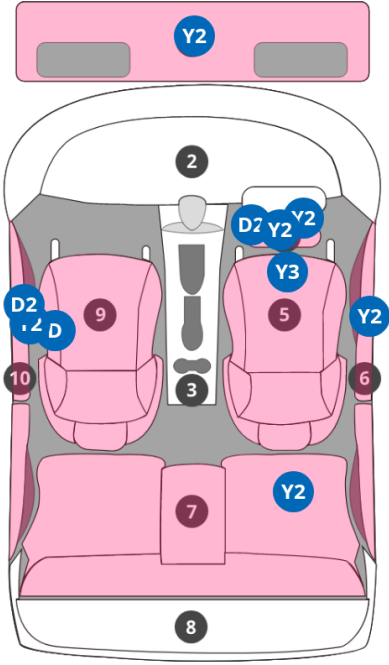
Interior Evaluation : C	Exterior Evaluation : C

<p>a : Cut, Fray d : Loose, Deformed k : Animal Hair s : Smell t : Cigarette Burns x : Defective y : Stain</p>

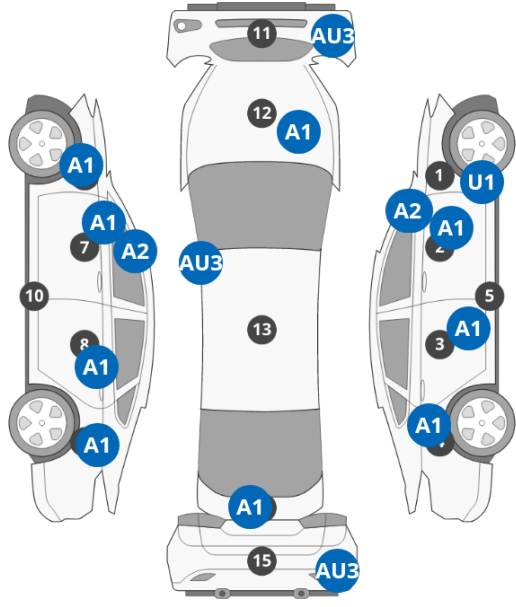
<p>A : Scratch AU : Scratch & Dent B : Modified C : Corrosion G : Stone chip P : Faded S : Rust SC : Rust & Corrosion U : Dent X : Defective Y : Crack, Gap</p>
<p>Remarks (R) Front Seat - Grime - Medium / (L) Front Seat - Worn - Yes / (R) Front Trim - Grime - Small / (L) Front Trim - Grime - Small / (L) Front Floor Mat - Worked - Small / (R) Front Floor Mat - Grime - Small / Ceiling - Grime - Small / Mat Other - Grime - Small / Rear Seat - Grime - Small / (L) Front Trim - Worked - Small</p>	<p>Remarks (R) Front Fender - Repair Traces - Yes / (R) Mirror - Crack - Damaged / (R) Mirror - Scratch - Small / (R) Front Fender, Molding - Dent - Minimal / (R) Front Door, Molding - Scratch - Minimal / (R) Rear Door, Molding - Scratch - Minimal / (R) Rear Fender, Molding - Scratch - Minimal / Rear Bumper, Lamps, Panels - Scratch & Dent - Medium / Trunk Hood, Rear Gate - Scratch - Minimal / (L) Rear Fender, Molding - Scratch - Minimal / (L) Rear Door, Molding - Scratch - Minimal / (L) Mirror - Scratch - Minimal / (L) Front Fender, Molding - Scratch - Minimal / Front Bumper, Grille, Lamps - Scratch & Dent - Medium / Bonnet, Headlight - Scratch - Minimal / Roof - Scratch & Dent - Medium / (L) Front Door, Molding - Scratch - Small</p>
