## General Information

| Make | Toyota | Model | Vios |

## Body / Panel Condition

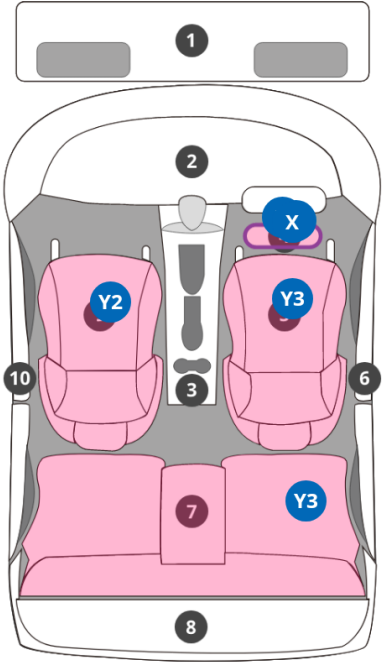
| Interior Evaluation : <b>B</b> | Exterior Evaluation : <b>C</b> |
| <b>Remarks</b><br>Rear Seat - Grime - Medium / (R) Front Seat - Grime - Medium / (L) Front Seat - Grime - Small / Mat Other - Missing - Yes / (R) Front Floor Mat - Missing - Yes / (L) Front Floor Mat - Missing - Yes | <b>Remarks</b><br>(R) Front Fender - Repair Traces - Yes / Front Bumper, Grille, Lamps - Scratch & Dent - Large / (L) Step, In-panel, Side Spoiler - Scratch & Dent - Large / (L) Front Door, Molding - Dent - Minimal / (L) Rear Fender, Molding - Dent - Minimal / (L) Rear Door, Molding - Dent - Small / Rear Bumper, Lamps, Panels - Scratch - Large / (R) Step, In-panel, Side Spoiler - Scratch & Dent - Large / (R) Front Fender, Molding - Scratch - Small |
