General Information

Make	Toyota	Model	Vios
YOM	2025	Odo Meter Reading	9,707
Registration No.	NHS8482	Chassis No.	PA1B18F32R4269231
CC	1.3	Transmission	CVT
Fuel Type	Gas	Type of Body	Sedan
Colour	Black

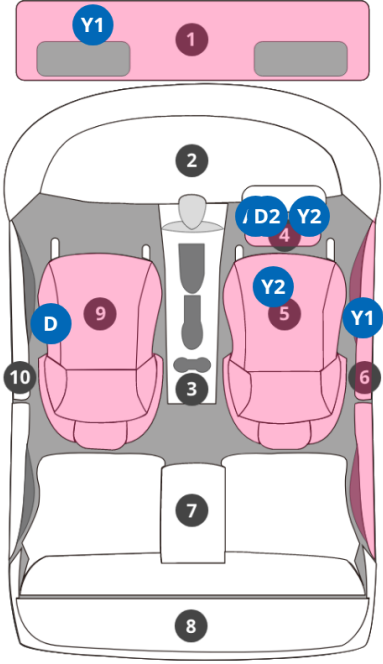
Interior Evaluation : B	Exterior Evaluation : C

<p>a : Cut, Fray d : Loose, Deformed k : Animal Hair s : Smell t : Cigarette Burns x : Defective y : Stain</p>

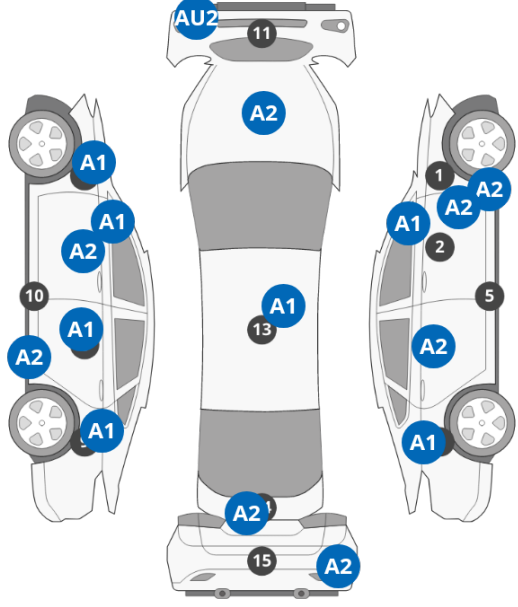
<p>A : Scratch AU : Scratch & Dent B : Modified C : Corrosion G : Stone chip P : Faded S : Rust SC : Rust & Corrosion U : Dent X : Defective Y : Crack, Gap</p>
<p>Remarks (R) Front Seat - Grime - Small / (L) Front Seat - Worn - Yes / (R) Front Trim - Grime - Minimal / Ceiling - Grime - Minimal / (R) Front Floor Mat - Grime - Small / (L) Front Floor Mat - Cut, Crack - Small / (L) Front Floor Mat - Worked - Small</p>	<p>Remarks (R) Mirror - Scratch - Minimal / (R) Front Fender, Molding - Scratch - Small / (R) Front Door, Molding - Scratch - Small / (R) Rear Door, Molding - Scratch - Small / (R) Rear Fender, Molding - Scratch - Minimal / Rear Bumper, Lamps, Panels - Scratch - Small / Trunk Hood, Rear Gate - Scratch - Small / (L) Rear Fender, Molding - Scratch - Minimal / (L) Rear Door, Molding - Scratch - Minimal / (L) Step, In-panel, Side Spoiler - Scratch - Small / (L) Front Door, Molding - Scratch - Small / (L) Mirror - Scratch - Minimal / (L) Front Fender, Molding - Scratch - Minimal / Front Bumper, Grille, Lamps - Scratch & Dent - Small / Bonnet, Headlight - Scratch - Small / Roof - Scratch - Minimal</p>
