General Information

Make	Toyota	Model	Vios
YOM	2025	Odo Meter Reading	15,804
Registration No.	NHU3668	Chassis No.	PA1B18F39R4270196
CC	1.3	Transmission	CVT
Fuel Type	Gas	Type of Body	Sedan
Colour	Black

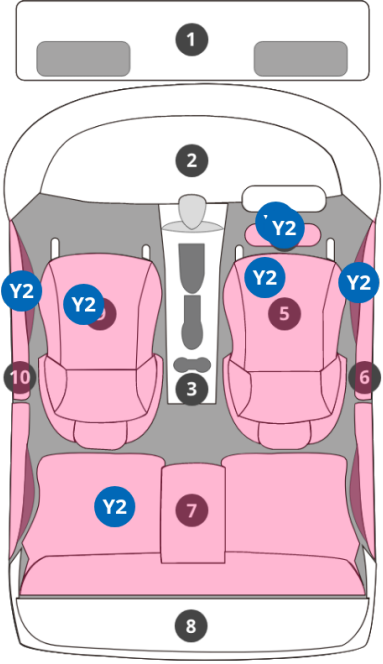
Interior Evaluation : B	Exterior Evaluation : D

<p>a : Cut, Fray d : Loose, Deformed k : Animal Hair s : Smell t : Cigarette Burns x : Defective y : Stain</p>

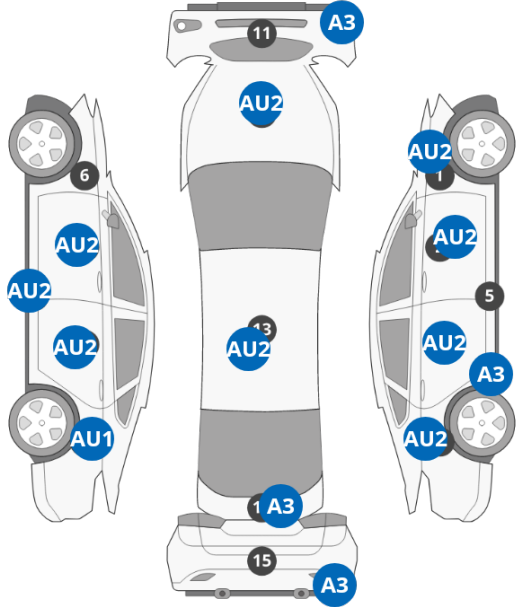
<p>A : Scratch AU : Scratch & Dent B : Modified C : Corrosion G : Stone chip P : Faded S : Rust SC : Rust & Corrosion U : Dent X : Defective Y : Crack, Gap</p>
<p>Remarks (L) Front Floor Mat - Grime - Small / (R) Front Floor Mat - Grime - Small / (L) Front Seat - Grime - Small / (R) Front Seat - Grime - Small / Rear Seat - Grime - Small / (L) Front Trim - Grime - Small / (R) Front Trim - Grime - Small</p>	<p>Remarks Trunk Hood, Rear Gate - Scratch - Medium / (L) Rear Fender, Molding - Scratch & Dent - Minimal / Roof - Scratch & Dent - Small / (L) Rear Door, Molding - Scratch & Dent - Small / (L) Front Door, Molding - Scratch & Dent - Small / (L) Step, In-panel, Side Spoiler - Scratch & Dent - Small / Bonnet, Headlight - Scratch & Dent - Small / Front Bumper, Grille, Lamps - Scratch - Medium / (R) Front Fender, Molding - Scratch & Dent - Small / (R) Front Door, Molding - Scratch & Dent - Small / (R) Rear Door, Molding - Scratch & Dent - Small / (R) Step, In-panel, Side Spoiler - Scratch - Medium / (R) Rear Fender, Molding - Scratch & Dent - Small / Rear Bumper, Lamps, Panels - Scratch - Medium</p>
