General Information

Make	Toyota	Model	Vios
YOM	2025	Odo Meter Reading	21,418
Registration No.	NHU8466	Chassis No.	PA1B18F32R4269052
CC	1.3	Transmission	CVT
Fuel Type	Gas	Type of Body	Sedan
Colour	Black

Body / Panel Condition

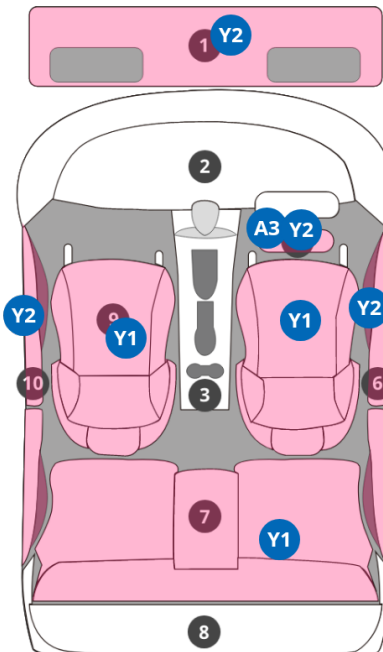
Interior Evaluation : B	Exterior Evaluation : E

<p>a : Cut, Fray d : Loose, Deformed k : Animal Hair s : Smell t : Cigarette Burns x : Defective y : Stain</p>

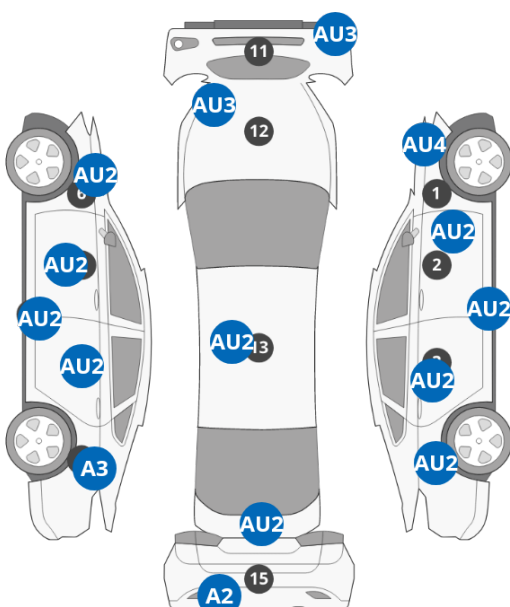
<p>A : Scratch AU : Scratch & Dent B : Modified C : Corrosion G : Stone chip P : Faded S : Rust SC : Rust & Corrosion U : Dent X : Defective Y : Crack, Gap</p>
<p>Remarks (L) Front Floor Mat - Cut, Crack - Medium / (R) Front Floor Mat - Grime - Small / (L) Front Seat - Grime - Minimal / (R) Front Seat - Grime - Minimal / Rear Seat - Grime - Minimal / (L) Front Trim - Grime - Small / (R) Front Trim - Grime - Small / Ceiling - Grime - Small</p>	<p>Remarks (L) Rear Fender, Molding - Scratch - Medium / Roof - Scratch & Dent - Small / (L) Rear Door, Molding - Scratch & Dent - Small / (L) Front Door, Molding - Scratch & Dent - Small / (L) Front Fender, Molding - Scratch & Dent - Small / Bonnet, Headlight - Scratch & Dent - Medium / Front Bumper, Grille, Lamps - Scratch & Dent - Medium / (R) Front Fender, Molding - Scratch & Dent - Large / (R) Front Door, Molding - Scratch & Dent - Small / (R) Rear Door, Molding - Scratch & Dent - Small / (R) Step, In-panel, Side Spoiler - Scratch & Dent - Small / (R) Rear Fender, Molding - Scratch & Dent - Small / Trunk Hood, Rear Gate - Scratch & Dent - Small / Rear Bumper, Lamps, Panels - Scratch - Small / (L) Step, In-panel, Side Spoiler - Scratch & Dent - Small</p>
