General Information

Make	Toyota	Model	Vios
YOM	2025	Odo Meter Reading	16,778
Registration No.	NJA1792	Chassis No.	PA1B18F33R4271179
CC	1.3	Transmission	CVT
Fuel Type	Gas	Type of Body	Sedan
Colour	Red

Body / Panel Condition

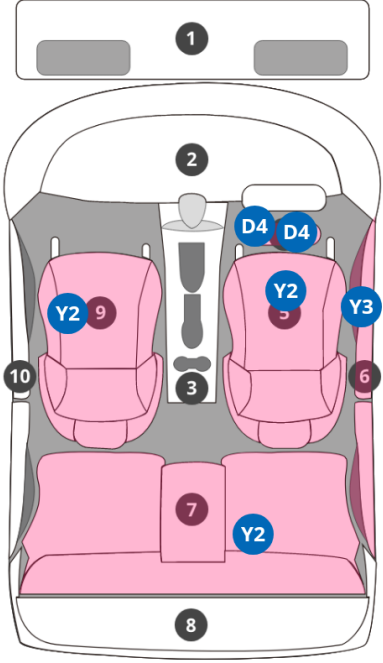
Interior Evaluation : C	Exterior Evaluation : D

<p>a : Cut, Fray d : Loose, Deformed k : Animal Hair s : Smell t : Cigarette Burns x : Defective y : Stain</p>

<p>A : Scratch AU : Scratch & Dent B : Modified C : Corrosion G : Stone chip P : Faded S : Rust SC : Rust & Corrosion U : Dent X : Defective Y : Crack, Gap</p>
<p>Remarks (R) Front Floor Mat - Worked - Large / (R) Front Trim - Grime - Medium / Rear Seat - Grime - Small / (L) Front Floor Mat - Worked - Large / (L) Front Seat - Grime - Small / (R) Front Seat - Grime - Small</p>	<p>Remarks Front Bumper, Grille, Lamps - Scratch - Large / (L) Front Fender, Molding - Scratch - Medium / (L) Front Door, Molding - Scratch - Small / (L) Rear Door, Molding - Scratch - Small / (L) Rear Fender, Molding - Dent - Small / Bonnet, Headlight - Scratch - Small / (R) Front Fender, Molding - Scratch - Small / (R) Front Door, Molding - Scratch - Medium / (R) Rear Door, Molding - Scratch - Medium / (R) Rear Fender, Molding - Scratch - Small / Rear Bumper, Lamps, Panels - Scratch - Large</p>
