## General Information

| <b>Make</b> | Toyota | <b>Model</b> | Vios |

## Body / Panel Condition

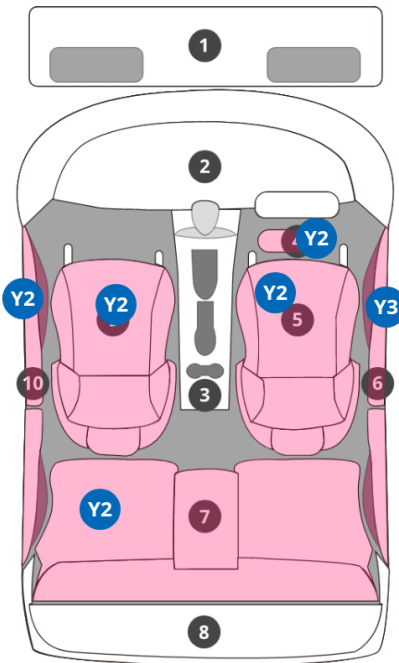
| <b>Interior Evaluation :</b> <span style="float: right; color: red; font-weight: bold;">B</span> | <b>Exterior Evaluation :</b> <span style="float: right; color: red; font-weight: bold;">C</span> |

| <p><b>Remarks</b><br/>(R) Front Seat - Grime - Small / (R) Front Trim - Grime - Medium / Rear Seat - Grime - Small / (L) Front Trim - Grime - Small / (L) Front Floor Mat - Grime - Small / (L) Front Seat - Grime - Small</p> | <p><b>Remarks</b><br/>Rear Bumper, Lamps, Panels - Scratch - Large / (R) Rear Fender, Molding - Scratch - Small / (R) Rear Door, Molding - Scratch - Medium / (R) Front Door, Molding - Scratch - Minimal / Bonnet, Headlight - Scratch - Small / (R) Front Fender, Molding - Scratch - Minimal / Front Bumper, Grille, Lamps - Scratch - Medium / (L) Front Door, Molding - Scratch &amp; Dent - Medium / (L) Front Fender, Molding - Scratch - Minimal / (L) Rear Door, Molding - Scratch - Small / (L) Rear Fender, Molding - Scratch - Minimal / Trunk Hood, Rear Gate - Scratch - Minimal / Roof - Scratch - Minimal</p> |
