General Information

Make	Toyota	Model	Vios
YOM	2025	Odo Meter Reading	19,539
Registration No.	NJF3742	Chassis No.	PA1B18F36R4278563
CC	1.3	Transmission	CVT
Fuel Type	Gas	Type of Body	Sedan
Colour	Black

Body / Panel Condition

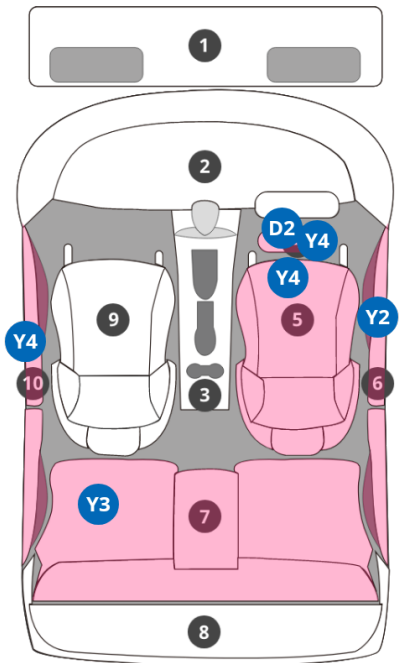
Interior Evaluation : C	Exterior Evaluation : E

<p>a : Cut, Fray d : Loose, Deformed k : Animal Hair s : Smell t : Cigarette Burns x : Defective y : Stain</p>

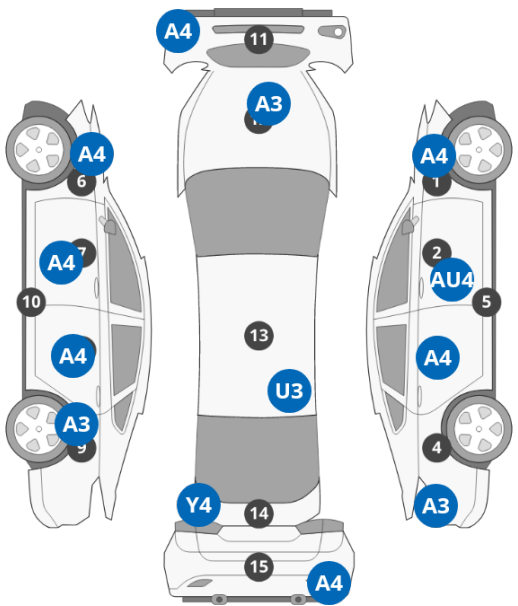
<p>A : Scratch AU : Scratch & Dent B : Modified C : Corrosion G : Stone chip P : Faded S : Rust SC : Rust & Corrosion U : Dent X : Defective Y : Crack, Gap</p>
<p>Remarks Mat Other - Grime - Large / Rear Seat - Grime - Medium / (L) Front Trim - Grime - Large / (L) Front Floor Mat - Worked - Small / (R) Front Seat - Grime - Large / (R) Front Trim - Grime - Small</p>	<p>Remarks Trunk Hood, Rear Gate - Crack, Gap - Large / Rear Bumper, Lamps, Panels - Scratch - Large / (R) Rear Fender, Molding - Scratch - Medium / (R) Rear Door, Molding - Scratch - Large / (R) Front Door, Molding - Scratch & Dent - Large / (R) Front Fender, Molding - Scratch - Large / Bonnet, Headlight - Scratch - Medium / Front Bumper, Grille, Lamps - Scratch - Large / Roof - Dent - Medium / (L) Front Fender, Molding - Scratch - Large / (L) Front Door, Molding - Scratch - Large / (L) Rear Door, Molding - Scratch - Large / (L) Rear Fender, Molding - Scratch - Medium</p>
