General Information

Make	Toyota	Model	Vios
YOM	2025	Odo Meter Reading	11,042
Registration No.	NJF7304	Chassis No.	PA1B18F30S4290438
CC	1.3	Transmission	CVT
Fuel Type	Gas	Type of Body	Sedan
Colour	Blue

Body / Panel Condition

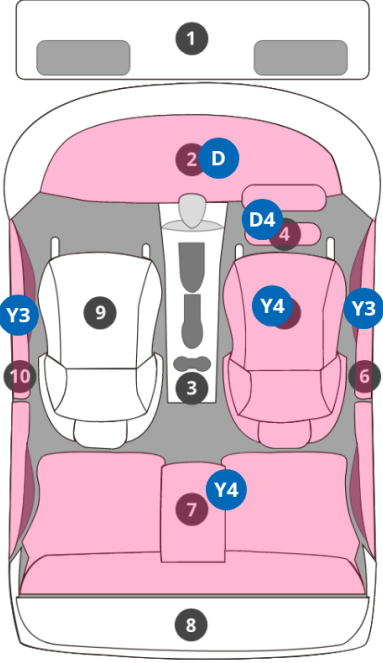
Interior Evaluation : C	Exterior Evaluation : E

<p>a : Cut, Fray d : Loose, Deformed k : Animal Hair s : Smell t : Cigarette Burns x : Defective y : Stain</p>

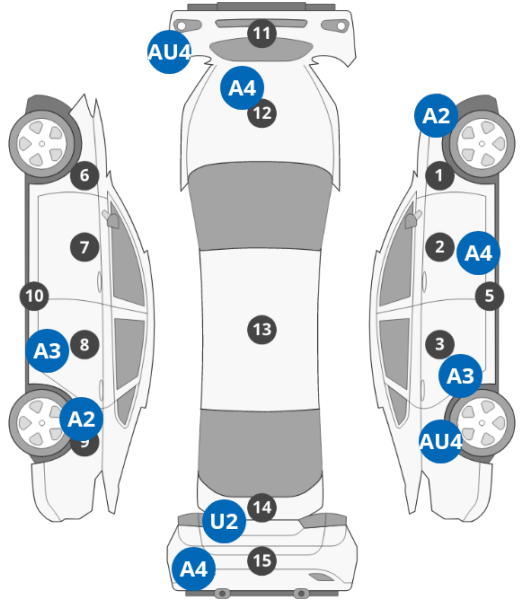
<p>A : Scratch AU : Scratch & Dent B : Modified C : Corrosion G : Stone chip P : Faded S : Rust SC : Rust & Corrosion U : Dent X : Defective Y : Crack, Gap</p>
<p>Remarks Rear Seat - Grime - Large / (R) Front Seat - Grime - Large / (R) Front Trim - Grime - Medium / (L) Front Floor Mat - Worked - Large / (L) Front Trim - Grime - Medium / Dashboard - Traces of Adhesive Tape - Yes</p>	<p>Remarks Front Bumper, Grille, Lamps - Scratch & Dent - Large / (L) Rear Door, Molding - Scratch - Medium / (L) Rear Fender, Molding - Scratch - Small / Rear Bumper, Lamps, Panels - Scratch - Large / Trunk Hood, Rear Gate - Dent - Small / (R) Rear Fender, Molding - Scratch & Dent - Large / (R) Rear Door, Molding - Scratch - Medium / (R) Front Door, Molding - Scratch - Large / (R) Front Fender, Molding - Scratch - Small / Bonnet, Headlight - Scratch - Large</p>
