General Information

Make	Toyota	Model	Vios
YOM	2025	Odo Meter Reading	9,322
Registration No.	NJF7390	Chassis No.	PA1B18F35S4289981
CC	1.3	Transmission	CVT
Fuel Type	Gas	Type of Body	Sedan
Colour	Red Mica Metallic

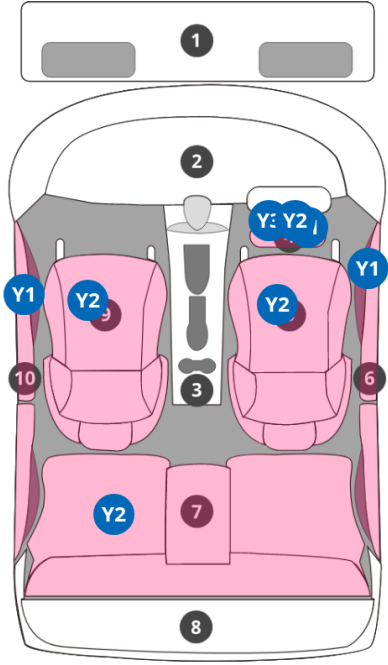
Interior Evaluation : B	Exterior Evaluation : D

<p>a : Cut, Fray d : Loose, Deformed k : Animal Hair s : Smell t : Cigarette Burns x : Defective y : Stain</p>

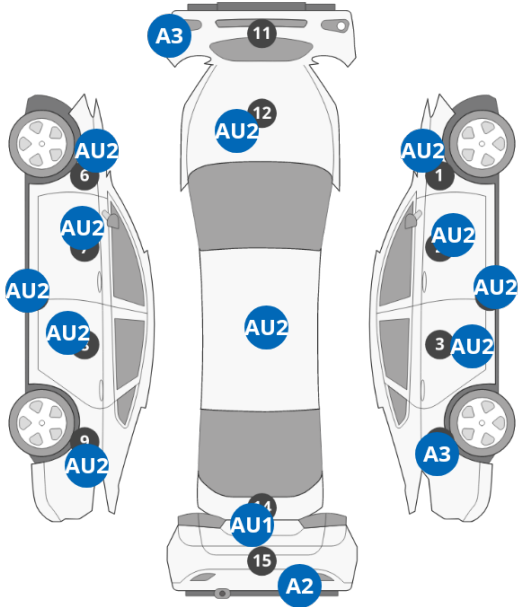
<p>A : Scratch AU : Scratch & Dent B : Modified C : Corrosion G : Stone chip P : Faded S : Rust SC : Rust & Corrosion U : Dent X : Defective Y : Crack, Gap</p>
<p>Remarks (L) Front Floor Mat - Grime - Medium / (L) Front Seat - Grime - Small / (R) Front Seat - Grime - Small / Rear Seat - Grime - Small / (R) Front Floor Mat - Grime - Minimal / Mat Other - Grime - Small / (L) Front Trim - Grime - Minimal / (R) Front Trim - Grime - Minimal</p>	<p>Remarks Bonnet, Headlight - Scratch & Dent - Small / (R) Front Fender, Molding - Scratch & Dent - Small / Front Bumper, Grille, Lamps - Scratch - Medium / Roof - Scratch & Dent - Small / (L) Rear Door, Molding - Scratch & Dent - Small / (L) Front Door, Molding - Scratch & Dent - Small / (L) Step, In-panel, Side Spoiler - Scratch & Dent - Small / (L) Rear Fender, Molding - Scratch & Dent - Small / Trunk Hood, Rear Gate - Scratch & Dent - Minimal / Rear Bumper, Lamps, Panels - Scratch - Small / (R) Rear Fender, Molding - Scratch - Medium / (R) Rear Door, Molding - Scratch & Dent - Small / (R) Step, In-panel, Side Spoiler - Scratch & Dent - Small / (R) Front Door, Molding - Scratch & Dent - Small / (L) Front Fender, Molding - Scratch & Dent - Small</p>

<p>Inspector Notes</p>
<p>with LTO plate, with spare tire, with tools and jack, with reverse camera, with spare key, with manual and warranty booklet, issue on taillight lens right side, scratches on headlight.</p>
