General Information

Make	Toyota	Model	Vios
YOM	2024	Odo Meter Reading	36,084
Registration No.	NKB7266	Chassis No.	PA1B18F32R4253224
CC	1.3	Transmission	CVT
Fuel Type	Gas	Type of Body	Sedan
Colour	Red Mica Metallic

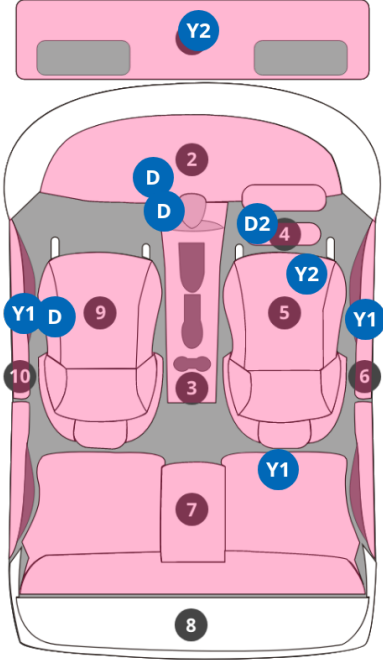
Interior Evaluation : B	Exterior Evaluation : E

<p>a : Cut, Fray d : Loose, Deformed k : Animal Hair s : Smell t : Cigarette Burns x : Defective y : Stain</p>

<p>A : Scratch AU : Scratch & Dent B : Modified C : Corrosion G : Stone chip P : Faded S : Rust SC : Rust & Corrosion U : Dent X : Defective Y : Crack, Gap</p>
<p>Remarks (L) Front Seat - Worn - Yes / (L) Front Trim - Grime - Minimal / (R) Front Trim - Grime - Minimal / (R) Front Seat - Grime - Small / Ceiling - Grime - Small / Rear Seat - Grime - Minimal / (L) Front Floor Mat - Worked - Small / Dashboard - Traces of Adhesive Tape - Yes / Console, Switchs, Vents - Traces of Adhesive Tape - Yes</p>	<p>Remarks (R) Front Fender, Molding - Scratch - Minimal / (R) Mirror - Scratch - Minimal / (R) Rear Door, Molding - Scratch & Dent - Medium / (R) Step, In-panel, Side Spoiler - Scratch - Small / (R) Front Door, Molding - Scratch - Minimal / (R) Rear Fender, Molding - Scratch & Dent - Large / Rear Bumper, Lamps, Panels - Scratch - Small / Trunk Hood, Rear Gate - Scratch - Minimal / (L) Rear Fender, Molding - Scratch - Small / (L) Rear Door, Molding - Scratch - Small / (L) Front Door, Molding - Scratch - Medium / (L) Mirror - Scratch - Small / (L) Front Fender, Molding - Scratch - Medium / Front Bumper, Grille, Lamps - Scratch - Small / Bonnet, Headlight - Scratch & Dent - Medium / Roof - Scratch - Small</p>

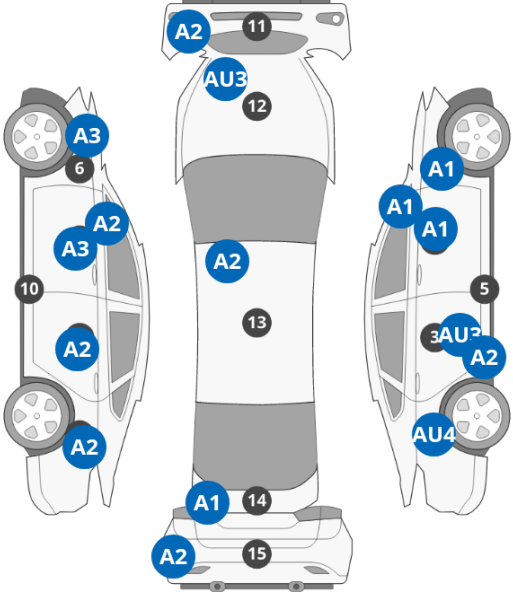
<p>Inspector Notes</p>	
<p>with warranty booklet, with jack, incomplete tools, with spare tire and LTO PLATE, scratches on tail light</p>
