General Information

Make	Toyota	Model	Vios
YOM	2024	Odo Meter Reading	28,894
Registration No.	DBM1697	Chassis No.	PA1B18F36R4240735
CC	1.3	Transmission	CVT
Fuel Type	Gas	Type of Body	Sedan
Colour	Black

Body / Panel Condition

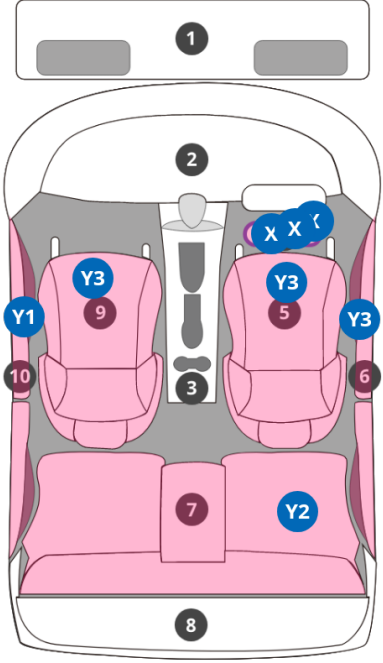
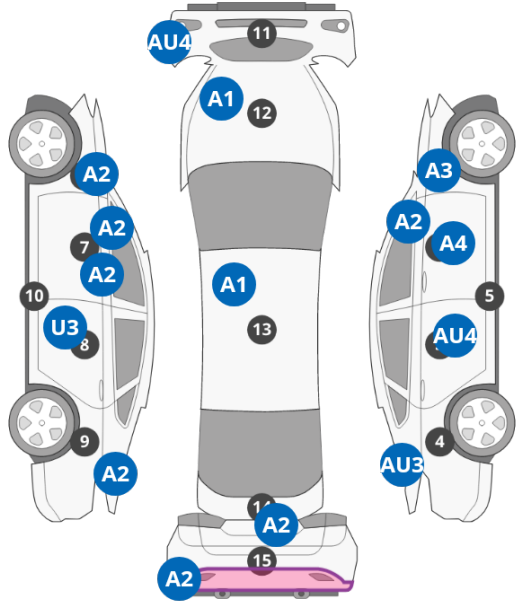
Interior Evaluation :	B	Exterior Evaluation :	E

<p>a : Cut, Fray d : Loose, Deformed k : Animal Hair s : Smell t : Cigarette Burns x : Defective y : Stain</p>		<p>A : Scratch AU : Scratch & Dent B : Modified C : Corrosion G : Stone chip P : Faded S : Rust SC : Rust & Corrosion U : Dent X : Defective Y : Crack, Gap</p>	
<p>Remarks (R) Front Seat - Grime - Medium / (L) Front Seat - Grime - Medium / (L) Front Floor Mat - Missing - Yes / (R) Front Floor Mat - Missing - Yes / Mat Other - Missing - Yes / (R) Front Trim - Grime - Medium / (L) Front Trim - Grime - Minimal / Rear Seat - Grime - Small</p>		<p>Remarks (R) Front Fender - Repair Traces - Yes / (L) Front Door - Repair Traces - Yes / (R) Rear Fender - Repair Traces - Yes / (R) Front Fender, Molding - Scratch - Medium / (R) Front Door, Molding - Scratch - Large / (R) Rear Door, Molding - Scratch & Dent - Large / (R) Mirror - Scratch - Small / (R) Rear Fender, Molding - Scratch & Dent - Medium / Rear Bumper, Lamps, Panels - Scratch - Small / Rear Bumper, Lamps, Panels - Repair mark - Yes / Trunk Hood, Rear Gate - Scratch - Small / (L) Rear Fender, Molding - Scratch - Small / (L) Mirror - Scratch - Small / (L) Rear Door, Molding - Dent - Medium / (L) Front Door, Molding - Scratch - Small / (L) Front Fender, Molding - Scratch - Small / Front Bumper, Grille, Lamps - Scratch & Dent - Large / Bonnet, Headlight - Scratch - Minimal / Roof - Scratch - Minimal</p>

Inspector Notes
no warranty booklet, jack and tools, no spare tire, with LTO plate, scratches on tail light
