General Information

Make	Toyota	Model	Vios
YOM	2025	Odo Meter Reading	8,582
Registration No.	DBP6217	Chassis No.	PA1B18F35R4264850
CC	1.3	Transmission	CVT
Fuel Type	Gas	Type of Body	Sedan
Colour	Silver

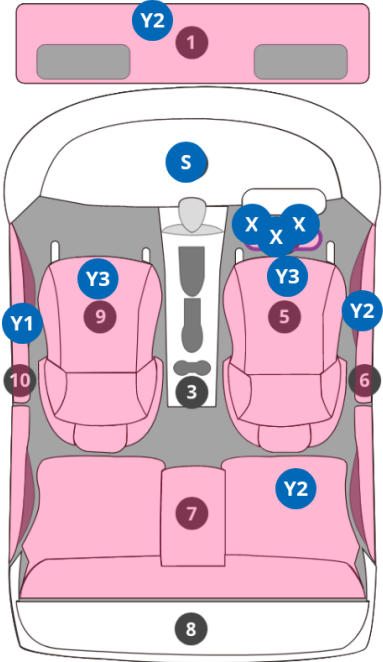
Interior Evaluation : B	Exterior Evaluation : E

<p>a : Cut, Fray d : Loose, Deformed k : Animal Hair s : Smell t : Cigarette Burns x : Defective y : Stain</p>

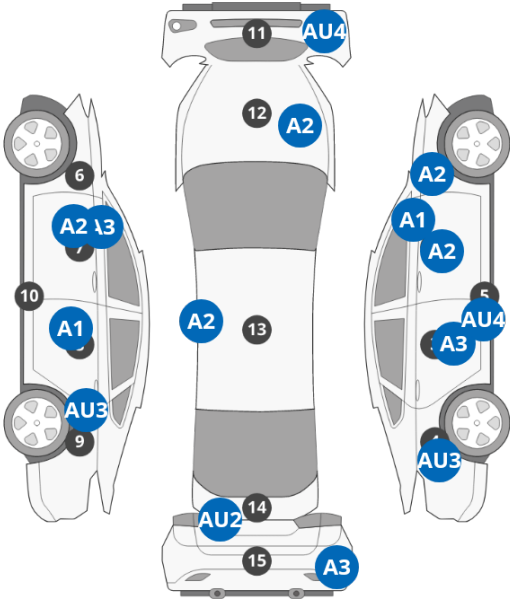
<p>A : Scratch AU : Scratch & Dent B : Modified C : Corrosion G : Stone chip P : Faded S : Rust SC : Rust & Corrosion U : Dent X : Defective Y : Crack, Gap</p>
<p>Remarks (R) Front Seat - Grime - Medium / (L) Front Seat - Grime - Medium / Overall Interior - Smell - Yes / Ceiling - Grime - Small / (L) Front Floor Mat - Missing - Yes / (R) Front Floor Mat - Missing - Yes / Mat Other - Missing - Yes / (R) Front Trim - Grime - Small / (L) Front Trim - Grime - Minimal / Rear Seat - Grime - Small</p>	<p>Remarks Trunk Hood, Rear Gate - Repair Traces - Yes / (R) Front Fender, Molding - Scratch - Small / (R) Mirror - Scratch - Minimal / (R) Front Door, Molding - Scratch - Small / (R) Rear Fender, Molding - Scratch & Dent - Medium / (R) Rear Door, Molding - Scratch - Medium / (R) Step, In-panel, Side Spoiler - Scratch & Dent - Large / Rear Bumper, Lamps, Panels - Scratch - Medium / Trunk Hood, Rear Gate - Scratch & Dent - Small / (L) Mirror - Scratch - Medium / (L) Front Door, Molding - Scratch - Small / (L) Rear Door, Molding - Scratch - Minimal / (L) Rear Fender, Molding - Scratch & Dent - Medium / Front Bumper, Grille, Lamps - Scratch & Dent - Large / Bonnet, Headlight - Scratch - Small / Roof - Scratch - Small</p>

<p>Inspector Notes</p>
<p>no warranty booklet, with jack, no tools, with spare, with LTO plate, scratched and cracked headlight and tail light, power steering issue due to weak battery</p>
