General Information

Make	Toyota	Model	Vios
YOM	2025	Odo Meter Reading	24,953
Registration No.	DBP9465	Chassis No.	PA1B18F38R4267306
CC	1.3	Transmission	CVT
Fuel Type	Gas	Type of Body	Sedan
Colour	Red

Body / Panel Condition

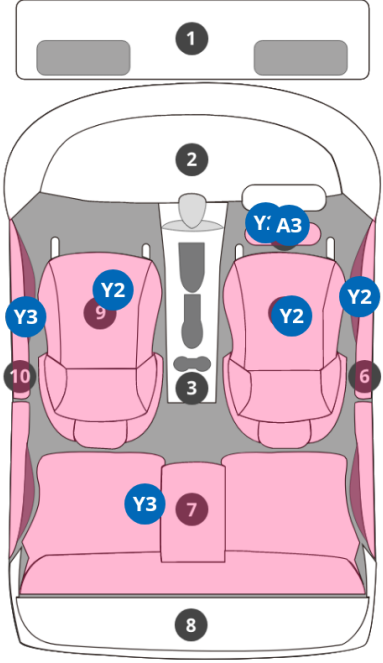
Interior Evaluation : C	Exterior Evaluation : D

<p>a : Cut, Fray d : Loose, Deformed k : Animal Hair s : Smell t : Cigarette Burns x : Defective y : Stain</p>

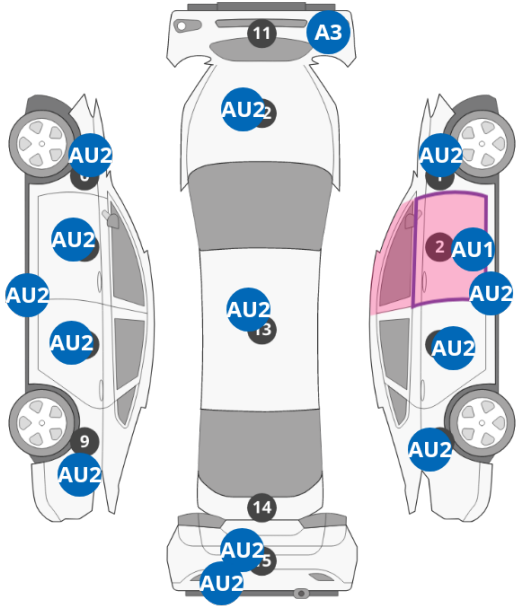
<p>A : Scratch AU : Scratch & Dent B : Modified C : Corrosion G : Stone chip P : Faded S : Rust SC : Rust & Corrosion U : Dent X : Defective Y : Crack, Gap</p>
<p>Remarks (R) Front Floor Mat - Grime - Small / (L) Front Floor Mat - Cut, Crack - Medium / (L) Front Trim - Grime - Medium / Rear Seat - Grime - Medium / (R) Front Trim - Grime - Small / (L) Front Seat - Grime - Small / (R) Front Seat - Grime - Small</p>	<p>Remarks Roof - Scratch & Dent - Small / (L) Rear Fender, Molding - Scratch & Dent - Small / Trunk Hood, Rear Gate - Scratch & Dent - Small / Rear Bumper, Lamps, Panels - Scratch & Dent - Small / (R) Rear Fender, Molding - Scratch & Dent - Small / (R) Rear Door, Molding - Scratch & Dent - Small / (R) Step, In-panel, Side Spoiler - Scratch & Dent - Small / (R) Front Door, Molding - Repair mark - Yes / (R) Front Door, Molding - Scratch & Dent - Minimal / (R) Front Fender, Molding - Scratch & Dent - Small / Bonnet, Headlight - Scratch & Dent - Small / (L) Front Door, Molding - Scratch & Dent - Small / (L) Rear Door, Molding - Scratch & Dent - Small / (L) Step, In-panel, Side Spoiler - Scratch & Dent - Small / (L) Front Fender, Molding - Scratch & Dent - Small / Front Bumper, Grille, Lamps - Scratch - Medium</p>

<p>Inspector Notes</p>
<p>with LTO plate, with spare tire, with spare key, with manual and warranty booklet, with reverse camera, issue on headlight and taillight lens, issue on side mirror left side missing trim.</p>
