General Information

Make	Toyota	Model	Vios
YOM	2025	Odo Meter Reading	8,877
Registration No.	DBS3408	Chassis No.	PA1B18F38R4274384
CC	1.3	Transmission	CVT
Fuel Type	Gas	Type of Body	Sedan
Colour	Silver

Body / Panel Condition

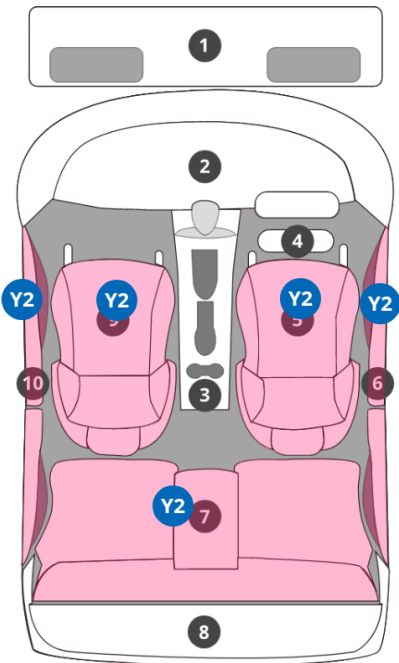
Interior Evaluation : B	Exterior Evaluation : C

<p>a : Cut, Fray d : Loose, Deformed k : Animal Hair s : Smell t : Cigarette Burns x : Defective y : Stain</p>

<p>A : Scratch AU : Scratch & Dent B : Modified C : Corrosion G : Stone chip P : Faded S : Rust SC : Rust & Corrosion U : Dent X : Defective Y : Crack, Gap</p>
<p>Remarks (L) Front Seat - Grime - Small / (R) Front Seat - Grime - Small / Rear Seat - Grime - Small / (L) Front Trim - Grime - Small / (R) Front Trim - Grime - Small</p>	<p>Remarks (L) Rear Door, Molding - Scratch & Dent - Minimal / (L) Rear Fender, Molding - Scratch & Dent - Small / (L) Front Door, Molding - Scratch & Dent - Minimal / Roof - Scratch & Dent - Small / Bonnet, Headlight - Scratch & Dent - Minimal / (R) Front Fender, Molding - Scratch & Dent - Minimal / (L) Front Fender, Molding - Scratch & Dent - Minimal / (R) Front Door, Molding - Scratch & Dent - Small / (R) Rear Door, Molding - Scratch & Dent - Small / (R) Step, In-panel, Side Spoiler - Scratch & Dent - Small / Trunk Hood, Rear Gate - Scratch & Dent - Small / (R) Rear Fender, Molding - Scratch & Dent - Small / Front Bumper, Grille, Lamps - Scratch & Dent - Small / (L) Step, In-panel, Side Spoiler - Scratch & Dent - Minimal</p>

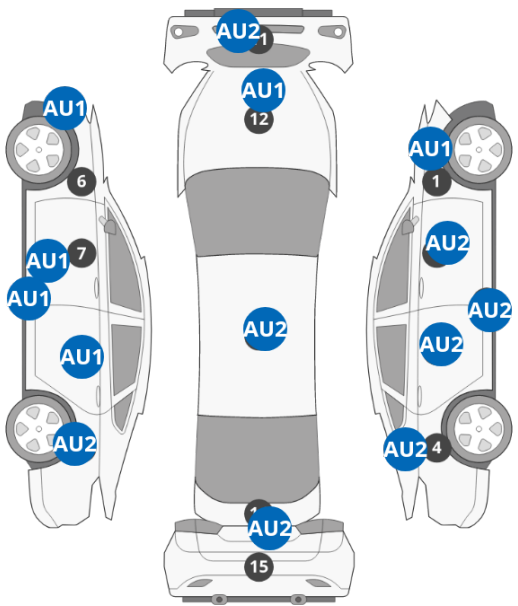
<p>Inspector Notes</p>
<p>with LTO plate, with spare tire, with spare key, with incomplete tools and jack, with reverse camera, with manual and warranty booklet, reverse light issue, scratches on taillight and headlight.</p>
