General Information

Make	Toyota	Model	Veloz
YOM	2025	Odo Meter Reading	14,069
Registration No.	DBT9797	Chassis No.	MHFAB1BY9S3136706
CC	1.5	Transmission	CVT
Fuel Type	Gas	Type of Body	Wagon
Colour	White

Body / Panel Condition

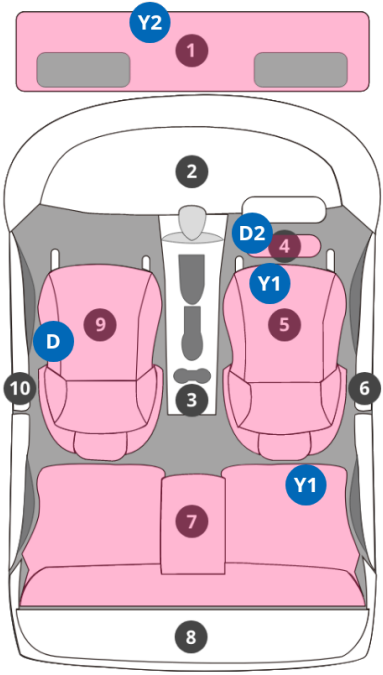
Interior Evaluation : B	Exterior Evaluation : B

<p>a : Cut, Fray d : Loose, Deformed k : Animal Hair s : Smell t : Cigarette Burns x : Defective y : Stain</p>

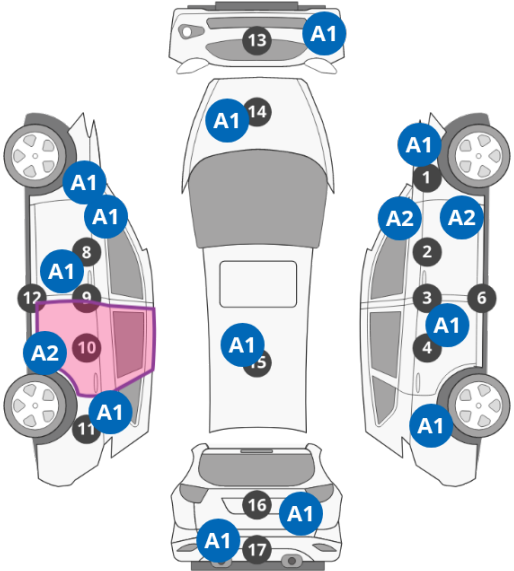
<p>A : Scratch AU : Scratch & Dent B : Modified C : Corrosion G : Stone chip P : Faded S : Rust SC : Rust & Corrosion U : Dent X : Defective Y : Crack, Gap</p>
<p>Remarks (L) Front Floor Mat - Worked - Small / (L) Front Seat - Worn - Yes / (R) Front Seat - Grime - Minimal / Ceiling - Grime - Small / Rear Seat - Grime - Minimal</p>	<p>Remarks (R) Mirror - Scratch - Small / (R) Front Door, Molding - Scratch - Small / (R) Front Fender, Molding - Scratch - Minimal / (R) Rear Door, Molding - Scratch - Minimal / (R) Rear Fender, Molding - Scratch - Minimal / Rear Bumper, Lamps, Panels - Scratch - Minimal / Trunk Hood, Rear Gate - Scratch - Minimal / (L) Rear Fender, Molding - Scratch - Minimal / (L) Rear Door, Molding - Repair mark - Yes / (L) Rear Door, Molding - Scratch - Small / (L) Front Door, Molding - Scratch - Minimal / (L) Mirror - Scratch - Minimal / (L) Front Fender, Molding - Scratch - Minimal / Front Bumper, Grille, Lamps - Scratch - Minimal / Bonnet, Headlight - Scratch - Minimal / Roof - Scratch - Minimal</p>
