General Information

Make	Toyota	Model	Vios
YOM	2025	Odo Meter Reading	14,182
Registration No.	CCA9935	Chassis No.	PA1B18F33R4263650
CC	1.3	Transmission	CVT
Fuel Type	Gas	Type of Body	Sedan
Colour	Black

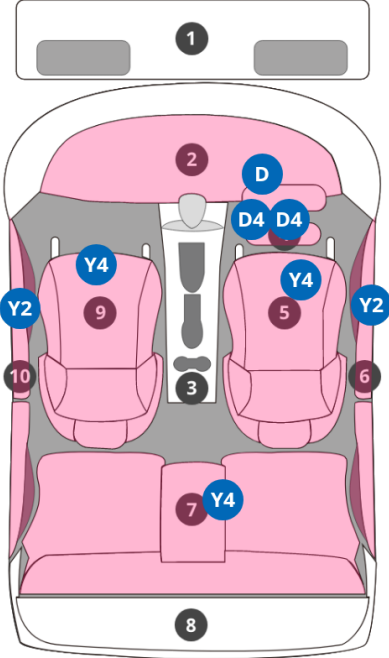
Interior Evaluation : D	Exterior Evaluation : E

<p>a : Cut, Fray d : Loose, Deformed k : Animal Hair s : Smell t : Cigarette Burns x : Defective y : Stain</p>

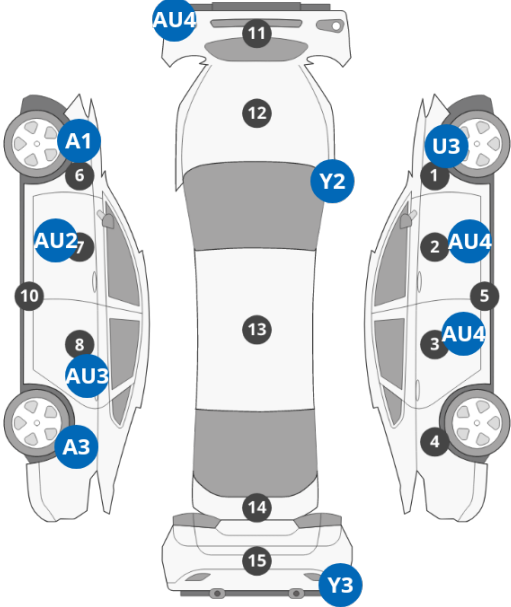
<p>A : Scratch AU : Scratch & Dent B : Modified C : Corrosion G : Stone chip P : Faded S : Rust SC : Rust & Corrosion U : Dent X : Defective Y : Crack, Gap</p>
<p>Remarks (R) Front Floor Mat - Worked - Large / (R) Front Seat - Grime - Large / (R) Front Trim - Grime - Small / (L) Front Trim - Grime - Small / (L) Front Floor Mat - Worked - Large / (L) Front Seat - Grime - Large / Dashboard - Traces of Adhesive Tape - Yes / Rear Seat - Grime - Large</p>	<p>Remarks Front Bumper, Grille, Lamps - Scratch & Dent - Large / (L) Front Door, Molding - Scratch & Dent - Small / (L) Rear Door, Molding - Scratch & Dent - Medium / (L) Rear Fender, Molding - Scratch - Medium / Rear Bumper, Lamps, Panels - Crack, Gap - Medium / (R) Front Door, Molding - Scratch & Dent - Large / (R) Rear Door, Molding - Scratch & Dent - Large / Bonnet, Headlight - Crack, Gap - Small / (R) Front Fender, Molding - Dent - Medium / (L) Front Fender, Molding - Scratch - Minimal</p>
