General Information

Make	Toyota	Model	Vios
YOM	2024	Odo Meter Reading	19,879
Registration No.	DBO4986	Chassis No.	PA1B18F36R4240086
CC	1.3	Transmission	CVT
Fuel Type	Gas	Type of Body	Sedan
Colour	Blue

Body / Panel Condition

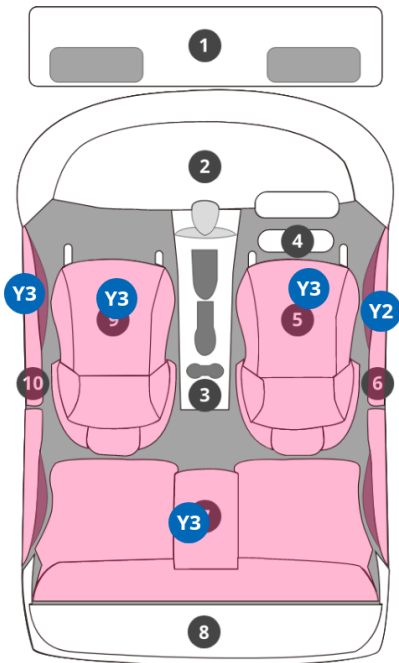
Interior Evaluation : B	Exterior Evaluation : E

<p>a : Cut, Fray d : Loose, Deformed k : Animal Hair s : Smell t : Cigarette Burns x : Defective y : Stain</p>

<p>A : Scratch AU : Scratch & Dent B : Modified C : Corrosion G : Stone chip P : Faded S : Rust SC : Rust & Corrosion U : Dent X : Defective Y : Crack, Gap</p>
<p>Remarks (R) Front Seat - Grime - Medium / (R) Front Trim - Grime - Small / Rear Seat - Grime - Medium / (L) Front Seat - Grime - Medium / (L) Front Trim - Grime - Medium</p>	<p>Remarks (L) Rear Door, Molding - Scratch & Dent - Medium / (L) Rear Fender, Molding - Scratch & Dent - Medium / (L) Front Door, Molding - Scratch - Medium / (L) Front Fender, Molding - Scratch & Dent - Medium / Bonnet, Headlight - Scratch - Medium / Front Bumper, Grille, Lamps - Scratch - Medium / Trunk Hood, Rear Gate - Scratch & Dent - Medium / Rear Bumper, Lamps, Panels - Scratch - Small / (R) Rear Fender, Molding - Scratch - Medium / (R) Rear Door, Molding - Scratch - Medium / (R) Step, In-panel, Side Spoiler - Scratch & Dent - Medium / (R) Front Door, Molding - Scratch - Medium / (R) Front Fender, Molding - Scratch - Small / (R) Mirror - Scratch - Minimal / (L) Mirror - Scratch - Minimal / Roof - Scratch - Minimal</p>
