General Information

Make	Toyota	Model	Vios
YOM	2025	Odo Meter Reading	12,846
Registration No.	DBQ5846	Chassis No.	PA1B18F30R4266019
CC	1.3	Transmission	CVT
Fuel Type	Gas	Type of Body	Sedan
Colour	Blue

Body / Panel Condition

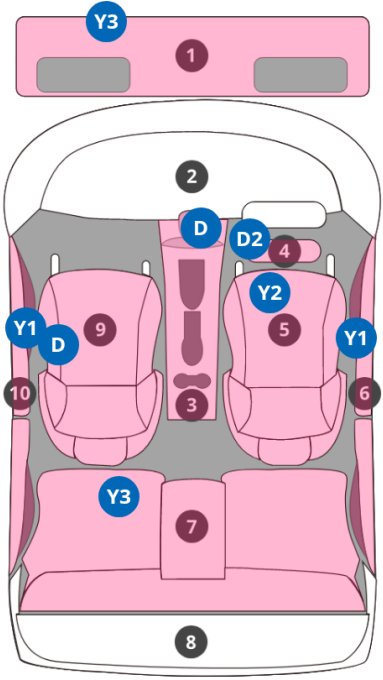
Interior Evaluation : C	Exterior Evaluation : C

<p>a : Cut, Fray d : Loose, Deformed k : Animal Hair s : Smell t : Cigarette Burns x : Defective y : Stain</p>

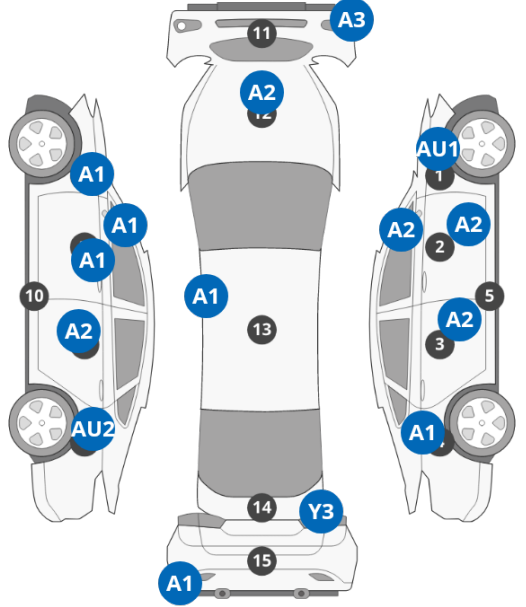
<p>A : Scratch AU : Scratch & Dent B : Modified C : Corrosion G : Stone chip P : Faded S : Rust SC : Rust & Corrosion U : Dent X : Defective Y : Crack, Gap</p>
<p>Remarks (L) Front Seat - Worn - Yes / (L) Front Floor Mat - Worked - Small / (R) Front Seat - Grime - Small / (L) Front Trim - Grime - Minimal / (R) Front Trim - Grime - Minimal / Rear Seat - Grime - Medium / Ceiling - Grime - Medium / Console, Switches, Vents - Traces of Adhesive Tape - Yes</p>	<p>Remarks (L) Rear Fender - Repair Traces - Yes / (R) Mirror - Scratch - Small / (R) Front Fender, Molding - Scratch & Dent - Minimal / (R) Front Door, Molding - Scratch - Small / (R) Rear Door, Molding - Scratch - Small / (R) Rear Fender, Molding - Scratch - Minimal / Rear Bumper, Lamps, Panels - Scratch - Minimal / (L) Mirror - Scratch - Minimal / (L) Rear Door, Molding - Scratch - Small / (L) Front Door, Molding - Scratch - Minimal / (L) Front Fender, Molding - Scratch - Minimal / Front Bumper, Grille, Lamps - Scratch - Medium / Bonnet, Headlight - Scratch - Small / (L) Rear Fender, Molding - Scratch & Dent - Small / Roof - Scratch - Minimal / Trunk Hood, Rear Gate - Crack, Gap - Medium</p>
