General Information

Make	Toyota	Model	Vios
YOM	2025	Odo Meter Reading	6,800
Registration No.	DBT4737	Chassis No.	PA1B18F39S4284704
CC	1.3	Transmission	CVT
Fuel Type	Gas	Type of Body	Sedan
Colour	Blue

Body / Panel Condition

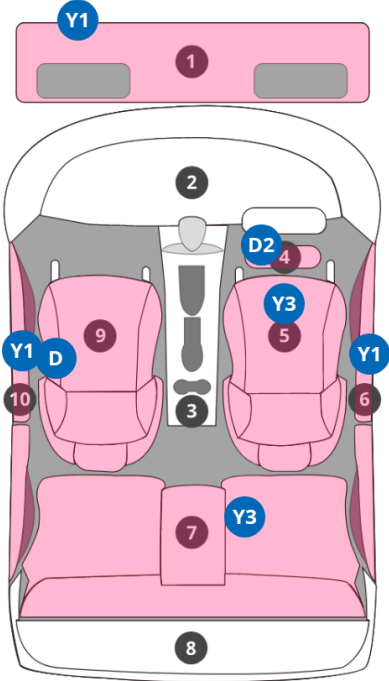
Interior Evaluation : B	Exterior Evaluation : B

<p>a : Cut, Fray d : Loose, Deformed k : Animal Hair s : Smell t : Cigarette Burns x : Defective y : Stain</p>

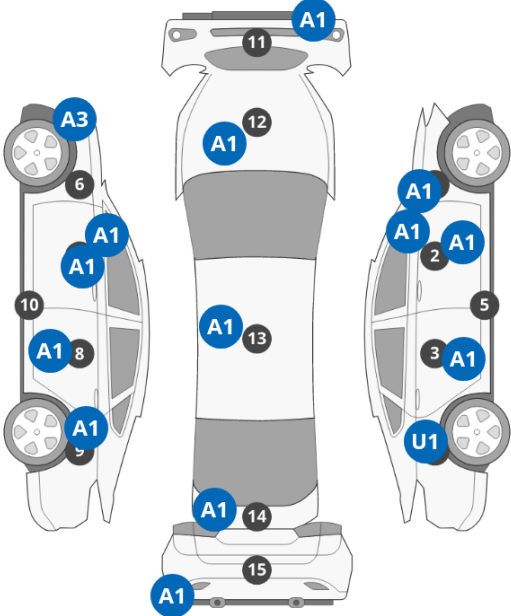
<p>A : Scratch AU : Scratch & Dent B : Modified C : Corrosion G : Stone chip P : Faded S : Rust SC : Rust & Corrosion U : Dent X : Defective Y : Crack, Gap</p>
<p>Remarks (R) Front Trim - Grime - Minimal / (L) Front Trim - Grime - Minimal / Rear Seat - Grime - Medium / (L) Front Floor Mat - Worked - Small / (L) Front Seat - Worn - Yes / (R) Front Seat - Grime - Medium / Ceiling - Grime - Minimal</p>	<p>Remarks (R) Mirror - Scratch - Minimal / (R) Front Fender, Molding - Scratch - Minimal / (R) Front Door, Molding - Scratch - Minimal / (R) Rear Door, Molding - Scratch - Minimal / (R) Rear Fender, Molding - Dent - Minimal / Rear Bumper, Lamps, Panels - Scratch - Minimal / Trunk Hood, Rear Gate - Scratch - Minimal / (L) Front Door, Molding - Scratch - Minimal / (L) Rear Fender, Molding - Scratch - Minimal / (L) Rear Door, Molding - Scratch - Minimal / (L) Mirror - Scratch - Minimal / (L) Front Fender, Molding - Scratch - Medium / Front Bumper, Grille, Lamps - Scratch - Minimal / Bonnet, Headlight - Scratch - Minimal / Roof - Scratch - Minimal</p>

<p>Inspector Notes</p>
<p>no warranty booklet, with jack, incomplete tools, with spare tire, with LTO plate, scratches on tail light</p>
