General Information

Make	Toyota	Model	Wigo
YOM	2025	Odo Meter Reading	20,242
Registration No.	DCA1911	Chassis No.	MHKAA1BC5SJ039457
CC	1.0	Transmission	CVT
Fuel Type	Gas	Type of Body	Hatchback
Colour	Silver

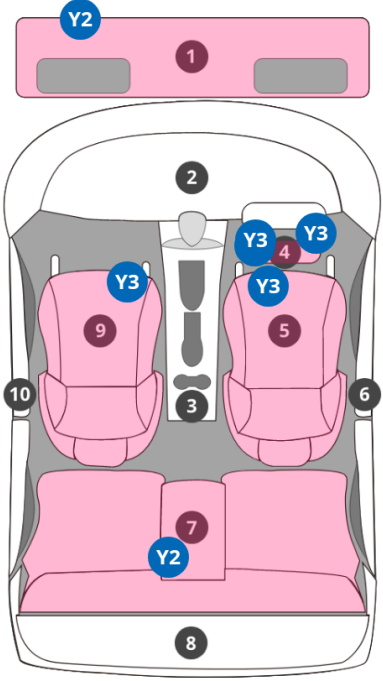
Interior Evaluation : C	Exterior Evaluation : E

<p>a : Cut, Fray d : Loose, Deformed k : Animal Hair s : Smell t : Cigarette Burns x : Defective y : Stain</p>

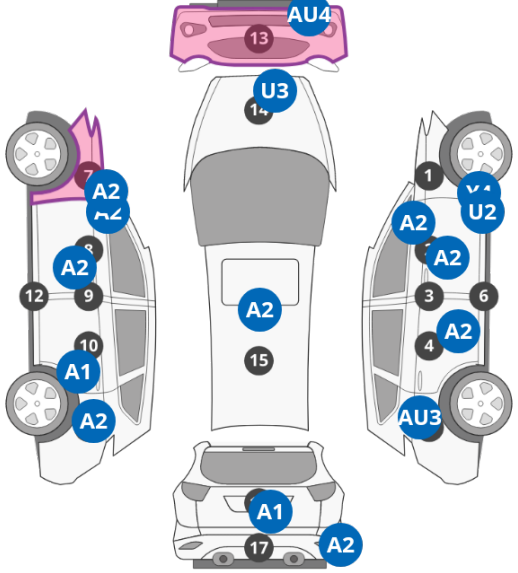
<p>A : Scratch AU : Scratch & Dent B : Modified C : Corrosion G : Stone chip P : Faded S : Rust SC : Rust & Corrosion U : Dent X : Defective Y : Crack, Gap</p>
<p>Remarks (L) Front Floor Mat - Worked - Small / (L) Front Floor Mat - Grime - Medium / (L) Front Seat - Grime - Medium / (R) Front Seat - Grime - Medium / Ceiling - Grime - Small / Rear Seat - Grime - Small / (R) Front Floor Mat - Grime - Medium</p>	<p>Remarks (R) Mirror - Scratch - Small / (R) Front Fender, Molding - Crack, Gap - Large / (R) Step, In-panel, Side Spoiler - Dent - Small / (R) Front Door, Molding - Scratch - Small / (R) Rear Door, Molding - Scratch - Small / (R) Rear Fender, Molding - Scratch & Dent - Medium / Rear Bumper, Lamps, Panels - Scratch - Small / Trunk Hood, Rear Gate - Scratch - Minimal / (L) Rear Fender, Molding - Scratch - Small / (L) Mirror - Scratch - Small / (L) Rear Door, Molding - Scratch - Minimal / (L) Front Door, Molding - Scratch - Small / (L) Front Fender, Molding - Repair mark - Yes / (L) Front Fender, Molding - Scratch - Small / Front Bumper, Grille, Lamps - Scratch & Dent - Large / Front Bumper, Grille, Lamps - Repair mark - Yes / Bonnet, Headlight - Dent - Medium / Roof - Scratch - Small</p>
