General Information

Make	Toyota	Model	Veloz
YOM	2024	Odo Meter Reading	40,703
Registration No.	EAG7025	Chassis No.	MHFAB1BY2P3081913
CC	1.5	Transmission	CVT
Fuel Type	Gas	Type of Body	SUV
Colour	Silver

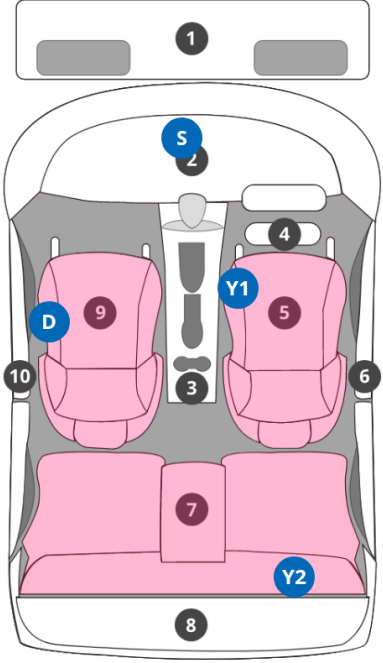
<p>a : Cut, Fray d : Loose, Deformed k : Animal Hair s : Smell t : Cigarette Burns x : Defective y : Stain</p>

<p>A : Scratch AU : Scratch & Dent B : Modified C : Corrosion G : Stone chip P : Faded S : Rust SC : Rust & Corrosion U : Dent X : Defective Y : Crack, Gap</p>
<p>Remarks (R) Front Seat - Grime - Minimal / (L) Front Seat - Worn - Yes / Rear Seat - Grime - Small / Overall Interior - Smell - Yes</p>	<p>Remarks (R) Mirror - Scratch - Minimal / (R) Front Fender, Molding - Scratch - Minimal / (R) Front Door, Molding - Scratch - Minimal / (R) Rear Door, Molding - Scratch - Minimal / (R) Rear Fender, Molding - Scratch - Minimal / Rear Bumper, Lamps, Panels - Scratch - Minimal / Trunk Hood, Rear Gate - Scratch - Minimal / (L) Rear Fender, Molding - Dent - Small / (L) Rear Door, Molding - Scratch - Minimal / (L) Front Door, Molding - Scratch - Minimal / (L) Mirror - Scratch - Minimal / (L) Front Fender, Molding - Scratch - Minimal / Front Bumper, Grille, Lamps - Scratch - Minimal / Bonnet, Headlight - Scratch - Minimal / Roof - Scratch - Small</p>

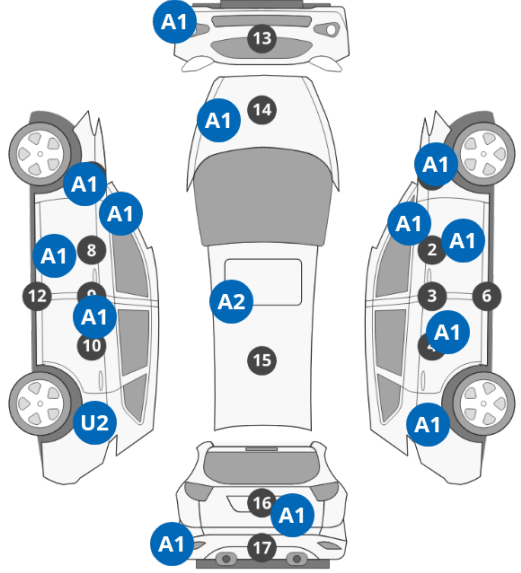
<p>Inspector Notes</p>
<p>with warranty booklet, with jack and tools, with spare tire, with LTO plate, scratches on tail light,</p>
