## General Information

<b>Make</b>	Toyota	<b>Model</b>	Vios
<b>YOM</b>	2025	<b>Odo Meter Reading</b>	2,514
<b>Registration No.</b>	EAL2378	<b>Chassis No.</b>	PA1B18F3XS4287045
<b>CC</b>	1.3	<b>Transmission</b>	CVT
<b>Fuel Type</b>	Gas	<b>Type of Body</b>	Sedan
<b>Colour</b>	Red

## Body / Panel Condition

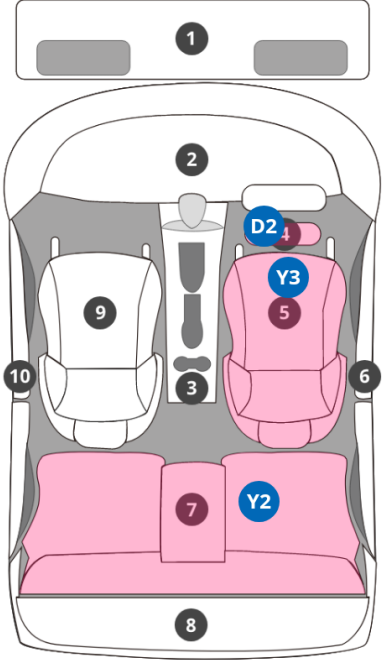
<b>Interior Evaluation :</b> <span style="float: right; color: red; font-weight: bold;">B</span>	<b>Exterior Evaluation :</b> <span style="float: right; color: red; font-weight: bold;">B</span>

<p><b>a</b> : Cut, Fray <b>d</b> : Loose, Deformed <b>k</b> : Animal Hair <b>s</b> : Smell <b>t</b> : Cigarette Burns <b>x</b> : Defective <b>y</b> : Stain</p>

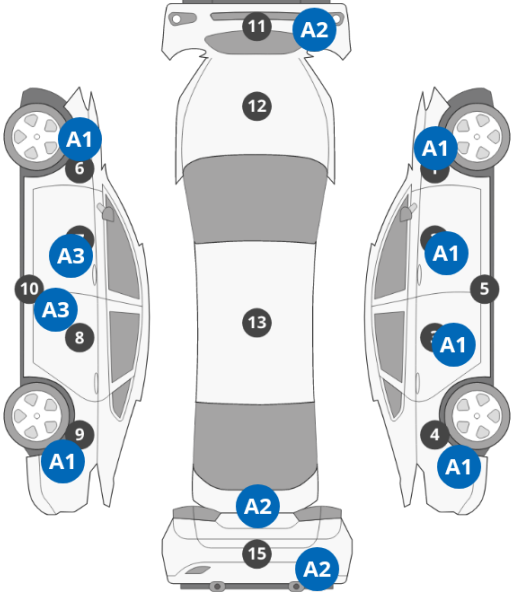
<p><b>A</b> : Scratch <b>AU</b> : Scratch &amp; Dent <b>B</b> : Modified <b>C</b> : Corrosion <b>G</b> : Stone chip <b>P</b> : Faded <b>S</b> : Rust <b>SC</b> : Rust &amp; Corrosion <b>U</b> : Dent <b>X</b> : Defective <b>Y</b> : Crack, Gap</p>
<p><b>Remarks</b> Rear Seat - Grime - Small / (R) Front Seat - Grime - Medium / (L) Front Floor Mat - Worked - Small</p>	<p><b>Remarks</b> (L) Rear Door, Molding - Scratch - Medium / (L) Front Door, Molding - Scratch - Medium / (L) Front Fender, Molding - Scratch - Minimal / Rear Bumper, Lamps, Panels - Scratch - Small / Front Bumper, Grille, Lamps - Scratch - Small / (R) Front Fender, Molding - Scratch - Minimal / (R) Front Door, Molding - Scratch - Minimal / (R) Rear Door, Molding - Scratch - Minimal / (L) Rear Fender, Molding - Scratch - Minimal / (R) Rear Fender, Molding - Scratch - Minimal / Trunk Hood, Rear Gate - Scratch - Small</p>
