General Information

Make	Toyota	Model	Vios
YOM	2024	Odo Meter Reading	24,623
Registration No.	NGC8620	Chassis No.	PA1B18F3XR4258199
CC	1.3	Transmission	CVT
Fuel Type	Gas	Type of Body	Sedan
Colour	Black

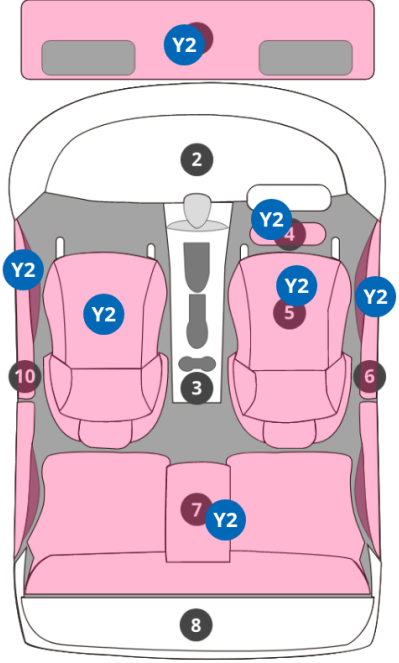
Interior Evaluation : B	Exterior Evaluation : C

<p>a : Cut, Fray d : Loose, Deformed k : Animal Hair s : Smell t : Cigarette Burns x : Defective y : Stain</p>

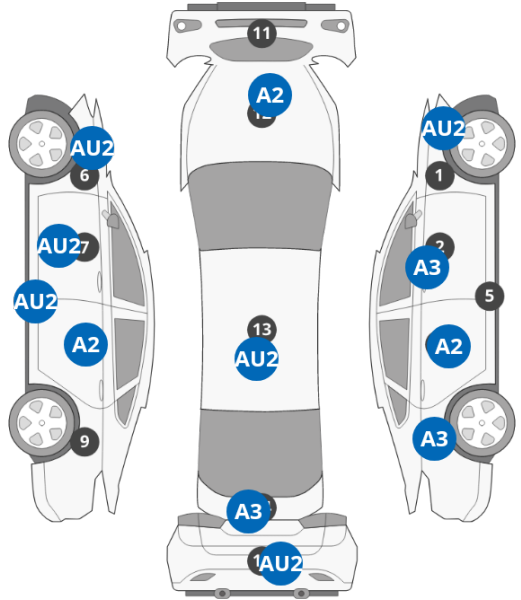
<p>A : Scratch AU : Scratch & Dent B : Modified C : Corrosion G : Stone chip P : Faded S : Rust SC : Rust & Corrosion U : Dent X : Defective Y : Crack, Gap</p>
<p>Remarks (L) Front Floor Mat - Grime - Small / (L) Front Seat - Grime - Small / (R) Front Seat - Grime - Small / Rear Seat - Grime - Small / (L) Front Trim - Grime - Small / (R) Front Trim - Grime - Small / Ceiling - Grime - Small</p>	<p>Remarks Roof - Scratch & Dent - Small / (L) Front Fender, Molding - Scratch & Dent - Small / Bonnet, Headlight - Scratch - Small / (R) Rear Fender, Molding - Scratch - Medium / (R) Rear Door, Molding - Scratch - Small / (R) Front Door, Molding - Scratch - Medium / Trunk Hood, Rear Gate - Scratch - Medium / Rear Bumper, Lamps, Panels - Scratch & Dent - Small / (L) Rear Door, Molding - Scratch - Small / (L) Front Door, Molding - Scratch & Dent - Small / (L) Step, In-panel, Side Spoiler - Scratch & Dent - Small / (R) Front Fender, Molding - Scratch & Dent - Small</p>
