General Information

Make	Toyota	Model	Avanza
YOM	2023	Odo Meter Reading	119,275
Registration No.	NHI3524	Chassis No.	MHFAA1BY2N0008185
CC	1.3	Transmission	M/T
Fuel Type	Gas	Type of Body	MPV
Colour	Black

Body / Panel Condition

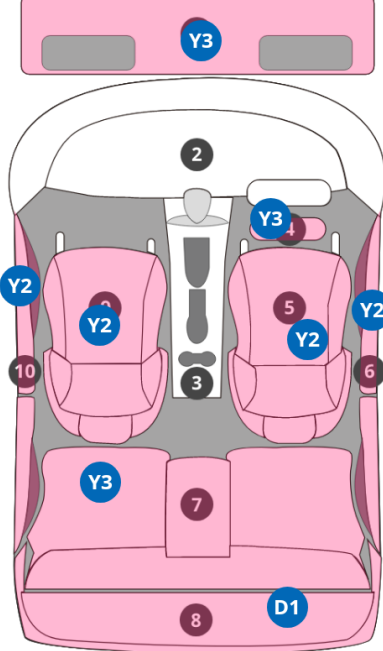
Interior Evaluation : C	Exterior Evaluation : E

<p>a : Cut, Fray d : Loose, Deformed k : Animal Hair s : Smell t : Cigarette Burns x : Defective y : Stain</p>

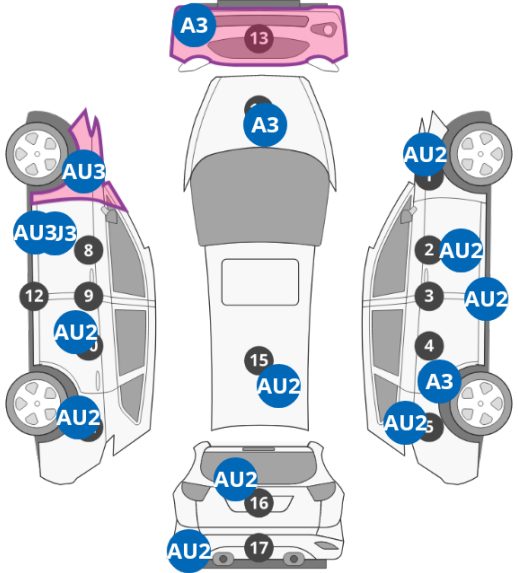
<p>A : Scratch AU : Scratch & Dent B : Modified C : Corrosion G : Stone chip P : Faded S : Rust SC : Rust & Corrosion U : Dent X : Defective Y : Crack, Gap</p>
<p>Remarks Rear Seat - Grime - Medium / Ceiling - Grime - Medium / (L) Front Floor Mat - Grime - Medium / (L) Front Seat - Grime - Small / (R) Front Seat - Grime - Small / (L) Front Trim - Grime - Small / (R) Front Trim - Grime - Small / Trunk Room - Worked - Minimal</p>	<p>Remarks (R) Front Fender - Repair Traces - Yes / (L) Front Fender - Repair Traces - Yes / (L) Rear Fender - Repair Traces - Yes / (L) Front Door, Molding - Scratch & Dent - Medium / (L) Step, In-panel, Side Spoiler - Scratch & Dent - Medium / (L) Rear Door, Molding - Scratch & Dent - Small / Roof - Scratch & Dent - Small / (L) Rear Fender, Molding - Scratch & Dent - Small / Rear Bumper, Lamps, Panels - Scratch & Dent - Small / Trunk Hood, Rear Gate - Scratch & Dent - Small / (R) Rear Fender, Molding - Scratch & Dent - Small / (R) Rear Door, Molding - Scratch - Medium / (R) Front Door, Molding - Scratch & Dent - Small / (R) Front Fender, Molding - Scratch & Dent - Small / Front Bumper, Grille, Lamps - Scratch - Medium / Front Bumper, Grille, Lamps - Repair mark - Yes / Bonnet, Headlight - Scratch - Medium / (L) Front Fender, Molding - Scratch & Dent - Medium / (L) Front Fender, Molding - Repair mark - Yes / (R) Step, In-panel, Side Spoiler - Scratch & Dent - Small</p>
