## General Information

<b>Make</b>	Toyota	<b>Model</b>	Vios
<b>YOM</b>	2024	<b>Odo Meter Reading</b>	20,842
<b>Registration No.</b>	NHS4403	<b>Chassis No.</b>	PA1B18F36R4258085
<b>CC</b>	1.3	<b>Transmission</b>	CVT
<b>Fuel Type</b>	Gas	<b>Type of Body</b>	Sedan
<b>Colour</b>	Red Mica Metallic

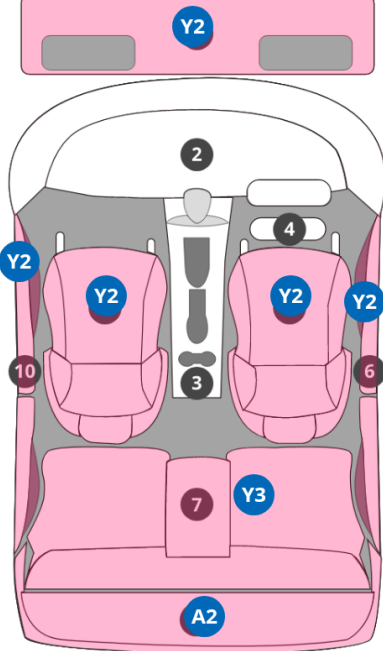
<b>Interior Evaluation :</b> <span style="float: right;"><b>B</b></span>	<b>Exterior Evaluation :</b> <span style="float: right;"><b>C</b></span>

<p><b>a</b> : Cut, Fray <b>d</b> : Loose, Deformed <b>k</b> : Animal Hair <b>s</b> : Smell <b>t</b> : Cigarette Burns <b>x</b> : Defective <b>y</b> : Stain</p>

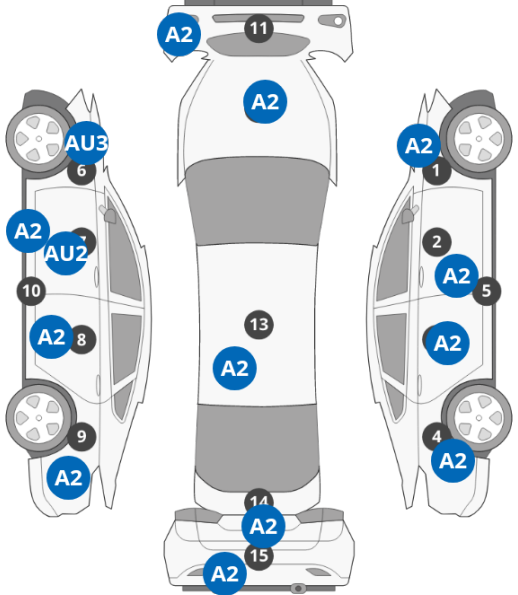
<p><b>A</b> : Scratch <b>AU</b> : Scratch &amp; Dent <b>B</b> : Modified <b>C</b> : Corrosion <b>G</b> : Stone chip <b>P</b> : Faded <b>S</b> : Rust <b>SC</b> : Rust &amp; Corrosion <b>U</b> : Dent <b>X</b> : Defective <b>Y</b> : Crack, Gap</p>
<p><b>Remarks</b> (R) Front Seat - Grime - Small / (R) Front Trim - Grime - Small / Rear Seat - Grime - Medium / (L) Front Trim - Grime - Small / (L) Front Seat - Grime - Small / Ceiling - Grime - Small / Trunk Room - Worn, Scratch, Cut, Crack - Small</p>	<p><b>Remarks</b> (L) Front Fender, Molding - Scratch &amp; Dent - Medium / Bonnet, Headlight - Scratch - Small / Front Bumper, Grille, Lamps - Scratch - Small / (L) Front Door, Molding - Scratch &amp; Dent - Small / (L) Step, In-panel, Side Spoiler - Scratch - Small / (L) Rear Door, Molding - Scratch - Small / Trunk Hood, Rear Gate - Scratch - Small / (R) Rear Fender, Molding - Scratch - Small / (R) Rear Door, Molding - Scratch - Small / (R) Front Door, Molding - Scratch - Small / Roof - Scratch - Small / (L) Rear Fender, Molding - Scratch - Small / Rear Bumper, Lamps, Panels - Scratch - Small / (R) Front Fender, Molding - Scratch - Small</p>
