General Information

Make	Toyota	Model	Wigo
YOM	2025	Odo Meter Reading	16,497
Registration No.	NHU9230	Chassis No.	MHKAA1BCORJ029414
CC	1.0	Transmission	CVT
Fuel Type	Gas	Type of Body	Hatchback
Colour	Gray

Body / Panel Condition

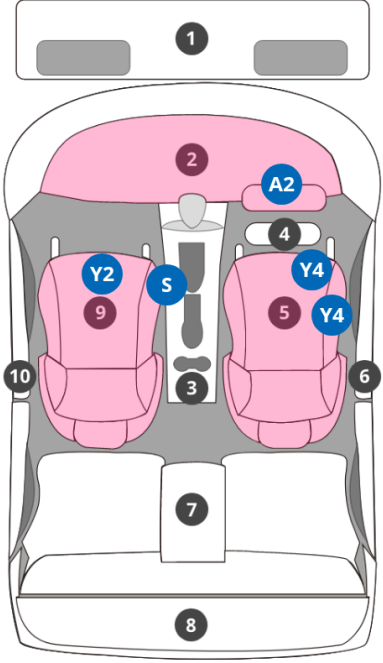
Interior Evaluation : C	Exterior Evaluation : E

<p>a : Cut, Fray d : Loose, Deformed k : Animal Hair s : Smell t : Cigarette Burns x : Defective y : Stain</p>

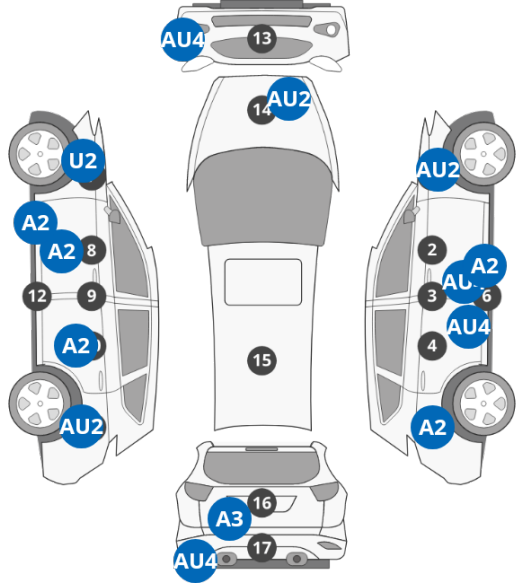
<p>A : Scratch AU : Scratch & Dent B : Modified C : Corrosion G : Stone chip P : Faded S : Rust SC : Rust & Corrosion U : Dent X : Defective Y : Crack, Gap</p>
<p>Remarks Overall Interior - Worn as per age - Yes / Overall Interior - Smell - Yes / (R) Front Seat - Grime - Large / (R) Front Seat belt - Grime - Large / Dashboard - Worn, Scratch, Cut, Crack - Small / (L) Front Seat - Grime - Small</p>	<p>Remarks Bonnet - Repair Traces - Yes / (L) Front Fender, Molding - Dent - Small / Bonnet, Headlight - Scratch & Dent - Small / Front Bumper, Grille, Lamps - Scratch & Dent - Large / (L) Front Door, Molding - Scratch - Small / (L) Step, In-panel, Side Spoiler - Scratch - Small / (L) Rear Door, Molding - Scratch - Small / Trunk Hood, Rear Gate - Scratch - Medium / Rear Bumper, Lamps, Panels - Scratch & Dent - Large / (R) Rear Door, Molding - Scratch & Dent - Large / (R) Front Door, Molding - Scratch & Dent - Large / (R) Step, In-panel, Side Spoiler - Scratch - Small / (R) Front Fender, Molding - Scratch & Dent - Small / (L) Rear Fender, Molding - Scratch & Dent - Small / (R) Rear Fender, Molding - Scratch - Small</p>
