General Information

Make	Toyota	Model	Raize
YOM	2025	Odo Meter Reading	14,588
Registration No.	NJA1048	Chassis No.	MHKAB1BAXRJ102316
CC	1.2	Transmission	CVT
Fuel Type	Gas	Type of Body	SUV
Colour	Red

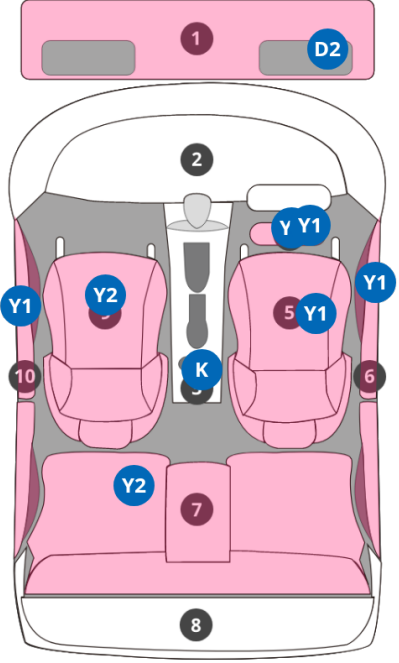
Interior Evaluation : B	Exterior Evaluation : D

<p>a : Cut, Fray d : Loose, Deformed k : Animal Hair s : Smell t : Cigarette Burns x : Defective y : Stain</p>

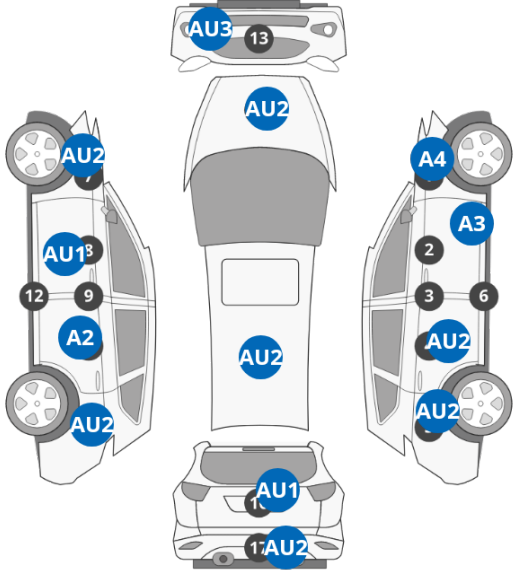
<p>A : Scratch AU : Scratch & Dent B : Modified C : Corrosion G : Stone chip P : Faded S : Rust SC : Rust & Corrosion U : Dent X : Defective Y : Crack, Gap</p>
<p>Remarks Overall Interior - Animal Hair - Yes / (L) Front Seat - Grime - Small / (R) Front Seat - Grime - Minimal / Rear Seat - Grime - Small / Sunvisor, Sunglass Holder - Crinkle - Small / (R) Front Floor Mat - Grime - Minimal / (L) Front Floor Mat - Grime - Minimal / (L) Front Trim - Grime - Minimal / (R) Front Trim - Grime - Minimal</p>	<p>Remarks Trunk Hood, Rear Gate - Scratch & Dent - Minimal / (L) Rear Fender, Molding - Scratch & Dent - Small / Roof - Scratch & Dent - Small / (L) Rear Door, Molding - Scratch - Small / (L) Front Door, Molding - Scratch & Dent - Minimal / (L) Front Fender, Molding - Scratch & Dent - Small / Bonnet, Headlight - Scratch & Dent - Small / (R) Front Fender, Molding - Scratch - Large / (R) Front Door, Molding - Scratch - Medium / (R) Rear Door, Molding - Scratch & Dent - Small / (R) Rear Fender, Molding - Scratch & Dent - Small / Rear Bumper, Lamps, Panels - Scratch & Dent - Small / Front Bumper, Grille, Lamps - Scratch & Dent - Medium</p>
