General Information

Make	Toyota	Model	Wigo
YOM	2025	Odo Meter Reading	4,113
Registration No.	NJA9441	Chassis No.	MHKAA1BC4SJ035870
CC	1.0	Transmission	CVT
Fuel Type	Gas	Type of Body	Hatchback
Colour	Red

Body / Panel Condition

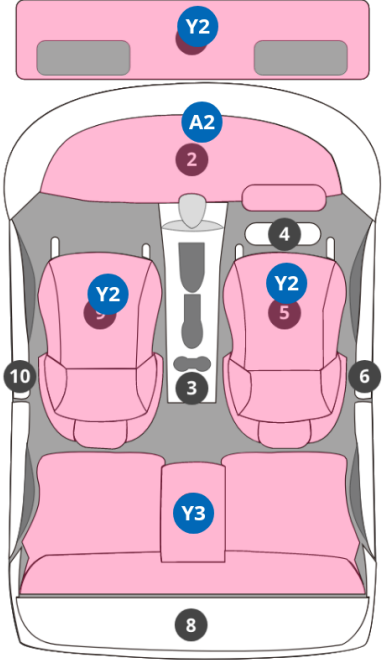
Interior Evaluation : B	Exterior Evaluation : C

<p>a : Cut, Fray d : Loose, Deformed k : Animal Hair s : Smell t : Cigarette Burns x : Defective y : Stain</p>

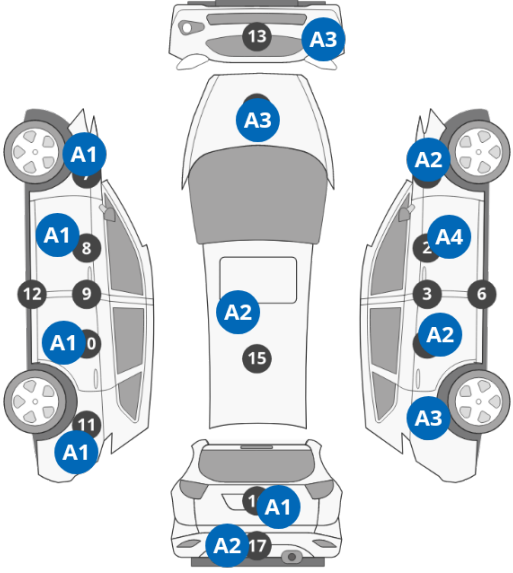
<p>A : Scratch AU : Scratch & Dent B : Modified C : Corrosion G : Stone chip P : Faded S : Rust SC : Rust & Corrosion U : Dent X : Defective Y : Crack, Gap</p>
<p>Remarks (L) Front Seat - Grime - Small / (R) Front Seat - Grime - Small / Dashboard - Worn, Scratch, Cut, Crack - Small / Rear Seat - Grime - Medium / Ceiling - Grime - Small</p>	<p>Remarks Bonnet, Headlight - Scratch - Medium / Front Bumper, Grille, Lamps - Scratch - Medium / (R) Front Fender, Molding - Scratch - Small / (R) Front Door, Molding - Scratch - Large / (R) Rear Door, Molding - Scratch - Small / (R) Rear Fender, Molding - Scratch - Medium / Roof - Scratch - Small / (L) Front Door, Molding - Scratch - Minimal / (L) Front Fender, Molding - Scratch - Minimal / (L) Rear Door, Molding - Scratch - Minimal / (L) Rear Fender, Molding - Scratch - Minimal / Trunk Hood, Rear Gate - Scratch - Minimal / Rear Bumper, Lamps, Panels - Scratch - Small</p>
