General Information

Make	Toyota	Model	Vios
YOM	2025	Odo Meter Reading	8,332
Registration No.	NJC9693	Chassis No.	PA1B18F37S4290677
CC	1.3	Transmission	CVT
Fuel Type	Gas	Type of Body	Sedan
Colour	Blue

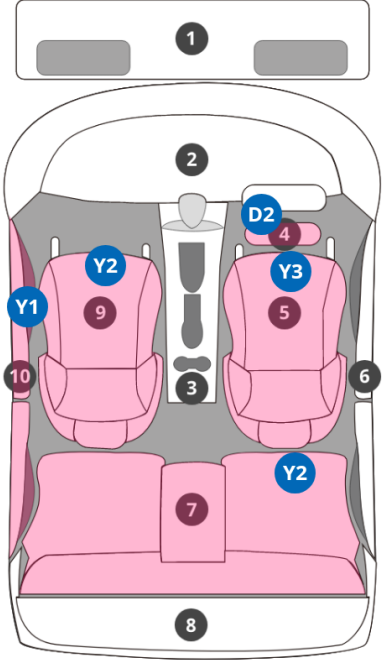
Interior Evaluation : B	Exterior Evaluation : B

<p>a : Cut, Fray d : Loose, Deformed k : Animal Hair s : Smell t : Cigarette Burns x : Defective y : Stain</p>

<p>A : Scratch AU : Scratch & Dent B : Modified C : Corrosion G : Stone chip P : Faded S : Rust SC : Rust & Corrosion U : Dent X : Defective Y : Crack, Gap</p>
<p>Remarks (L) Front Seat - Grime - Small / (R) Front Seat - Grime - Medium / (L) Front Trim - Grime - Minimal / (L) Front Floor Mat - Worked - Small / Rear Seat - Grime - Small</p>	<p>Remarks (R) Front Fender, Molding - Scratch - Minimal / (R) Mirror - Scratch - Minimal / (R) Rear Door, Molding - Scratch - Minimal / (R) Front Door, Molding - Scratch - Minimal / (R) Rear Fender, Molding - Scratch - Minimal / Rear Bumper, Lamps, Panels - Scratch - Small / Trunk Hood, Rear Gate - Dent - Minimal / (L) Rear Fender, Molding - Scratch - Minimal / (L) Mirror - Scratch - Minimal / (L) Rear Door, Molding - Scratch & Dent - Minimal / (L) Front Door, Molding - Scratch - Minimal / (L) Front Fender, Molding - Scratch - Minimal / Front Bumper, Grille, Lamps - Scratch - Small / Bonnet, Headlight - Scratch - Small / Roof - Scratch - Minimal</p>

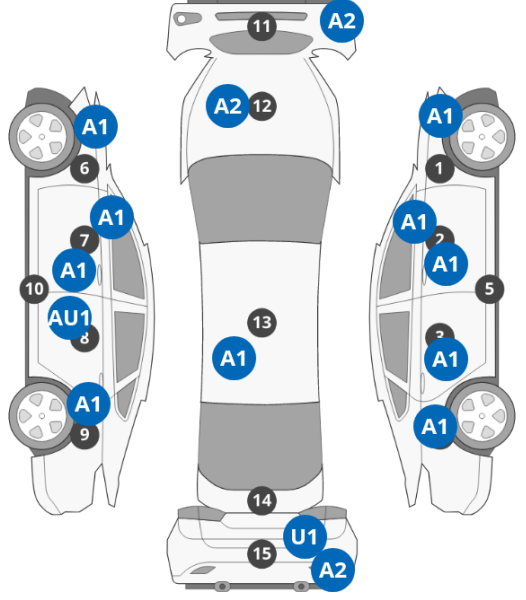
<p>Inspector Notes</p>
<p>with warranty booklet and jack, no tools, with spare tire, with LTO plate, scratches on tail light</p>
