General Information

Make	Toyota	Model	Vios
YOM	2025	Odo Meter Reading	24,305
Registration No.	NJF1058	Chassis No.	PA1B18F38R4270965
CC	1.3	Transmission	CVT
Fuel Type	Gas	Type of Body	Sedan
Colour	Red

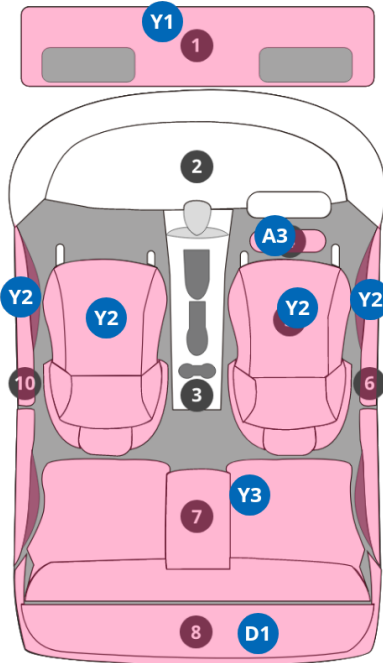
Interior Evaluation : B	Exterior Evaluation : E

<p>a : Cut, Fray d : Loose, Deformed k : Animal Hair s : Smell t : Cigarette Burns x : Defective y : Stain</p>

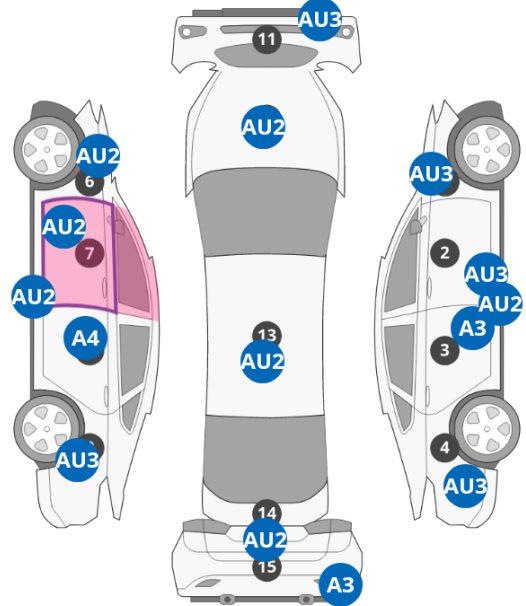
<p>A : Scratch AU : Scratch & Dent B : Modified C : Corrosion G : Stone chip P : Faded S : Rust SC : Rust & Corrosion U : Dent X : Defective Y : Crack, Gap</p>
<p>Remarks (L) Front Floor Mat - Cut, Crack - Medium / Rear Seat - Grime - Medium / (L) Front Seat - Grime - Small / (R) Front Seat - Grime - Small / (L) Front Trim - Grime - Small / (R) Front Trim - Grime - Small / Trunk Room - Worked - Minimal / Ceiling - Grime - Minimal</p>	<p>Remarks Bonnet - Repair Traces - Yes / (L) Front Door - Repair Traces - Yes / (L) Front Door, Molding - Scratch & Dent - Small / (L) Front Fender, Molding - Scratch & Dent - Small / (L) Step, In-panel, Side Spoiler - Scratch & Dent - Small / Bonnet, Headlight - Scratch & Dent - Small / Front Bumper, Grille, Lamps - Scratch & Dent - Medium / (R) Front Fender, Molding - Scratch & Dent - Medium / (R) Front Door, Molding - Scratch & Dent - Medium / (R) Rear Door, Molding - Scratch - Medium / (R) Step, In-panel, Side Spoiler - Scratch & Dent - Small / Roof - Scratch & Dent - Small / (R) Rear Fender, Molding - Scratch & Dent - Medium / Rear Bumper, Lamps, Panels - Scratch - Medium / Trunk Hood, Rear Gate - Scratch & Dent - Small / (L) Rear Fender, Molding - Scratch & Dent - Medium / (L) Rear Door, Molding - Scratch - Large</p>
