General Information

Make	Toyota	Model	Vios
YOM	2025	Odo Meter Reading	8,995
Registration No.	NJF5563	Chassis No.	PA1B18F38S4286573
CC	1.3	Transmission	CVT
Fuel Type	Gas	Type of Body	Sedan
Colour	Black

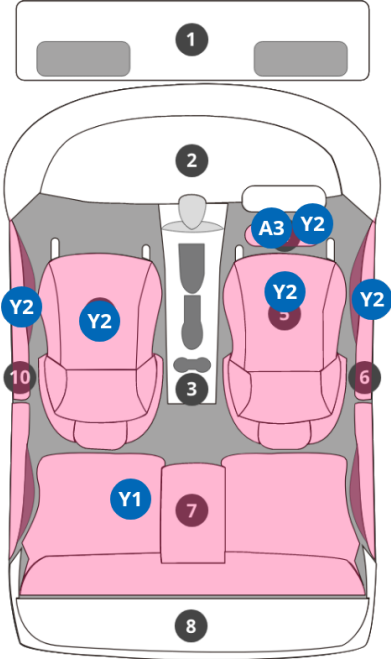
Interior Evaluation : B	Exterior Evaluation : D

<p>a : Cut, Fray d : Loose, Deformed k : Animal Hair s : Smell t : Cigarette Burns x : Defective y : Stain</p>

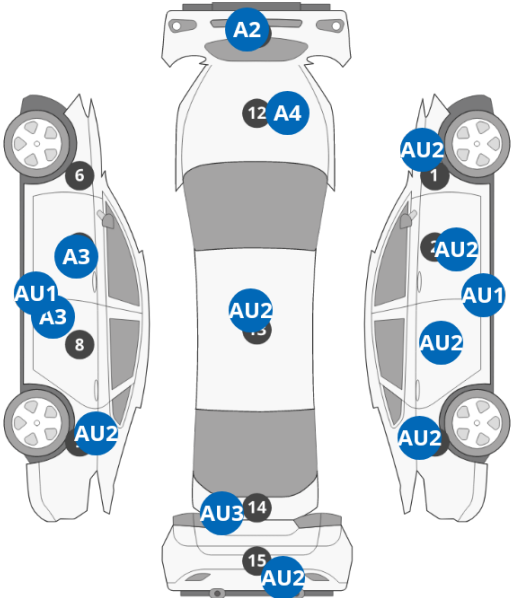
<p>A : Scratch AU : Scratch & Dent B : Modified C : Corrosion G : Stone chip P : Faded S : Rust SC : Rust & Corrosion U : Dent X : Defective Y : Crack, Gap</p>
<p>Remarks (L) Front Floor Mat - Cut, Crack - Medium / (L) Front Seat - Grime - Small / (R) Front Seat - Grime - Small / (L) Front Trim - Grime - Small / (R) Front Trim - Grime - Small / Rear Seat - Grime - Minimal / (R) Front Floor Mat - Grime - Small</p>	<p>Remarks Roof - Scratch & Dent - Small / (L) Front Door, Molding - Scratch - Medium / (L) Rear Door, Molding - Scratch - Medium / (L) Step, In-panel, Side Spoiler - Scratch & Dent - Minimal / (L) Rear Fender, Molding - Scratch & Dent - Small / Trunk Hood, Rear Gate - Scratch & Dent - Medium / Rear Bumper, Lamps, Panels - Scratch & Dent - Small / (R) Rear Fender, Molding - Scratch & Dent - Small / (R) Rear Door, Molding - Scratch & Dent - Small / (R) Step, In-panel, Side Spoiler - Scratch & Dent - Minimal / (R) Front Door, Molding - Scratch & Dent - Small / (R) Front Fender, Molding - Scratch & Dent - Small / Bonnet, Headlight - Scratch - Large / Front Bumper, Grille, Lamps - Scratch - Small</p>
