General Information

Make	Toyota	Model	Vios
YOM	2025	Odo Meter Reading	6,353
Registration No.	NKH2814	Chassis No.	PA1B18F39R4279139
CC	1.3	Transmission	CVT
Fuel Type	Gas	Type of Body	Sedan
Colour	Blue

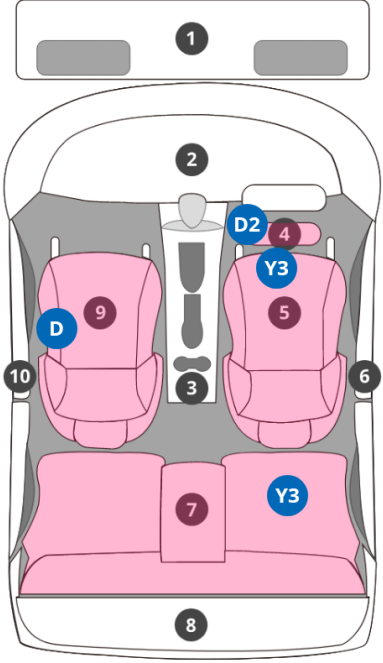
Interior Evaluation : B	Exterior Evaluation : C

<p>a : Cut, Fray d : Loose, Deformed k : Animal Hair s : Smell t : Cigarette Burns x : Defective y : Stain</p>

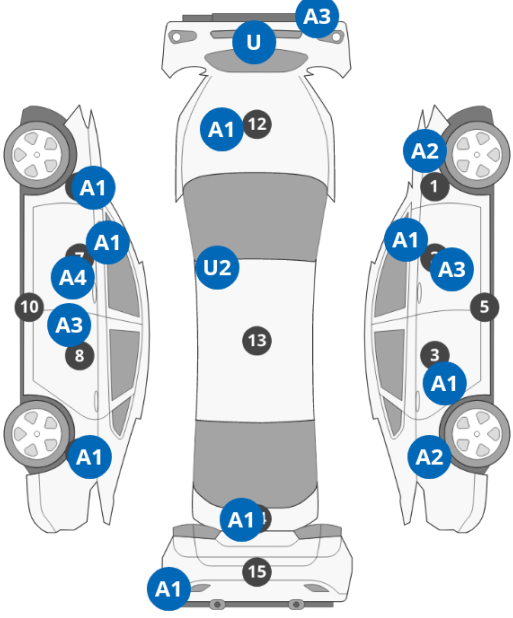
<p>A : Scratch AU : Scratch & Dent B : Modified C : Corrosion G : Stone chip P : Faded S : Rust SC : Rust & Corrosion U : Dent X : Defective Y : Crack, Gap</p>
<p>Remarks Rear Seat - Grime - Medium / (R) Front Seat - Grime - Medium / (L) Front Floor Mat - Worked - Small / (L) Front Seat - Worn - Yes</p>	<p>Remarks Member (Bolted) - Dent - Yes / (R) Front Fender, Molding - Scratch - Small / (R) Mirror - Scratch - Minimal / (R) Front Door, Molding - Scratch - Medium / (R) Rear Door, Molding - Scratch - Minimal / (R) Rear Fender, Molding - Scratch - Small / Rear Bumper, Lamps, Panels - Scratch - Minimal / (L) Mirror - Scratch - Minimal / (L) Rear Fender, Molding - Scratch - Minimal / (L) Rear Door, Molding - Scratch - Medium / (L) Front Door, Molding - Scratch - Large / (L) Front Fender, Molding - Scratch - Minimal / Front Bumper, Grille, Lamps - Scratch - Medium / Bonnet, Headlight - Scratch - Minimal / Roof - Dent - Small / Trunk Hood, Rear Gate - Scratch - Minimal</p>
