General Information

Make	Toyota	Model	Veloz
YOM	2024	Odo Meter Reading	12,910
Registration No.	NKI5102	Chassis No.	MHFAB1BY4R3106331
CC	1.5	Transmission	CVT
Fuel Type	Gas	Type of Body	SUV
Colour	White

Body / Panel Condition

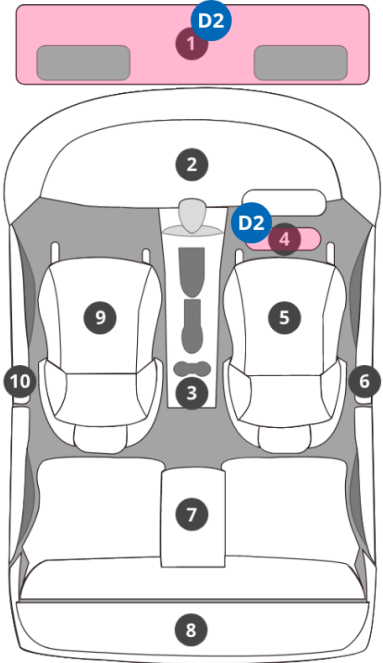
<p>a : Cut, Fray d : Loose, Deformed k : Animal Hair s : Smell t : Cigarette Burns x : Defective y : Stain</p>

<p>A : Scratch AU : Scratch & Dent B : Modified C : Corrosion G : Stone chip P : Faded S : Rust SC : Rust & Corrosion U : Dent X : Defective Y : Crack, Gap</p>
<p>Remarks (L) Front Floor Mat - Worked - Small / Ceiling - Crinkle - Small</p>	<p>Remarks (R) Mirror - Scratch - Small / (R) Front Fender, Molding - Scratch - Minimal / (R) Front Door, Molding - Scratch - Medium / (R) Rear Door, Molding - Scratch - Small / (R) Rear Fender, Molding - Scratch - Minimal / Rear Bumper, Lamps, Panels - Dent - Medium / Trunk Hood, Rear Gate - Scratch - Minimal / (L) Front Door, Molding - Scratch - Small / (L) Rear Door, Molding - Scratch - Minimal / (L) Mirror - Scratch - Small / (L) Front Fender, Molding - Scratch - Minimal / (L) Rear Fender, Molding - Scratch - Medium / Front Bumper, Grille, Lamps - Scratch - Small / Bonnet, Headlight - Scratch - Minimal / Roof - Scratch - Small</p>
