General Information

Make	Toyota	Model	Hilux Tamaraw
YOM	2025	Odo Meter Reading	11,101
Registration No.	NKQ3267	Chassis No.	PAHACACA0S6423883
CC	2.4	Transmission	M/T
Fuel Type	Diesel	Type of Body	Utility Passenger
Colour	White

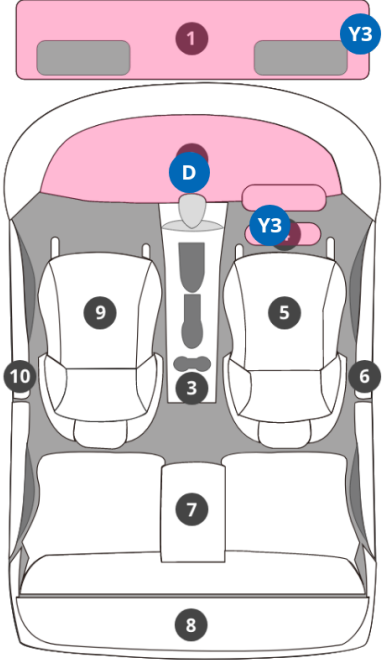
Interior Evaluation : B	Exterior Evaluation : D

<p>a : Cut, Fray d : Loose, Deformed k : Animal Hair s : Smell t : Cigarette Burns x : Defective y : Stain</p>

<p>A : Scratch AU : Scratch & Dent B : Modified C : Corrosion G : Stone chip P : Faded S : Rust SC : Rust & Corrosion U : Dent X : Defective Y : Crack, Gap</p>
<p>Remarks (L) Front Floor Mat - Grime - Medium / Ceiling - Grime - Medium / Dashboard - Traces of Adhesive Tape - Yes</p>	<p>Remarks (R) Front Fender, Molding - Scratch - Small / (R) Mirror - Scratch - Small / (R) Front Door, Molding - Scratch - Minimal / (R) Center Panel - Scratch - Minimal / (R) Side Gate - Scratch & Dent - Large / Rear Bumper, Lamps, Panels - Scratch - Small / Rear Gate - Scratch & Dent - Small / (L) Side Gate - Scratch & Dent - Large / (L) Front Door, Molding - Scratch - Small / (L) Mirror - Scratch - Minimal / Bonnet, Headlight - Scratch - Minimal / Cab Back Panel - Scratch & Dent - Small / Front Bumper, Grille, Lamps - Scratch - Medium / Cargo Bed Floor - Scratch & Dent - Large</p>

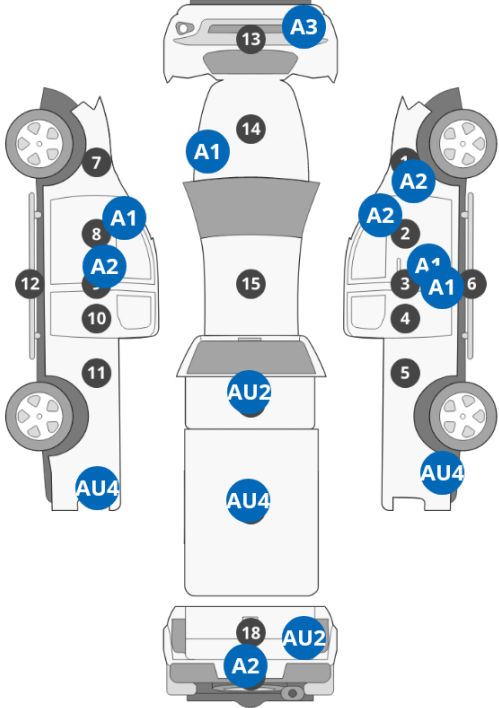
<p>Inspector Notes</p>
<p>with warranty booklet, jack and tools, with spare tire, with one LTO plate and one modified plate, scratches on tail light</p>
