## General Information

<b>Make</b>	Toyota	<b>Model</b>	Vios
<b>YOM</b>	2024	<b>Odo Meter Reading</b>	38,227
<b>Registration No.</b>	FAR8079	<b>Chassis No.</b>	PA1B18F31R4254364
<b>CC</b>	1.3	<b>Transmission</b>	CVT
<b>Fuel Type</b>	Gas	<b>Type of Body</b>	Sedan
<b>Colour</b>	Red Mica Metallic

## Body / Panel Condition

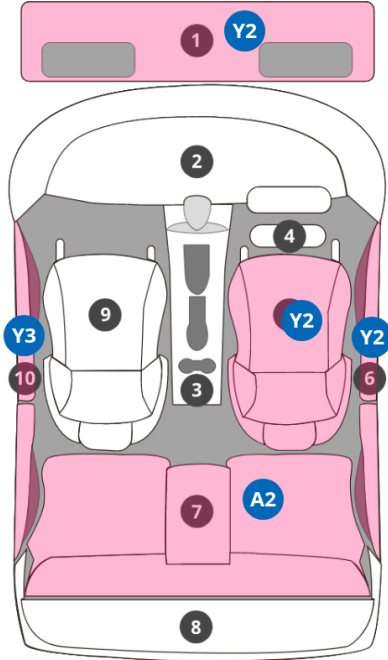
<b>Interior Evaluation :</b> <span style="float: right; color: red; font-weight: bold;">B</span>	<b>Exterior Evaluation :</b> <span style="float: right; color: red; font-weight: bold;">C</span>

<p><b>a</b> : Cut, Fray <b>d</b> : Loose, Deformed <b>k</b> : Animal Hair <b>s</b> : Smell <b>t</b> : Cigarette Burns <b>x</b> : Defective <b>y</b> : Stain</p>

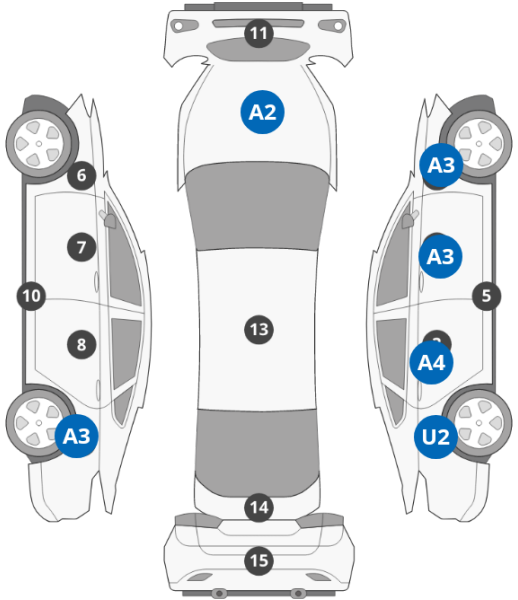
<p><b>A</b> : Scratch <b>AU</b> : Scratch &amp; Dent <b>B</b> : Modified <b>C</b> : Corrosion <b>G</b> : Stone chip <b>P</b> : Faded <b>S</b> : Rust <b>SC</b> : Rust &amp; Corrosion <b>U</b> : Dent <b>X</b> : Defective <b>Y</b> : Crack, Gap</p>
<p><b>Remarks</b> (L) Front Trim - Grime - Medium / (R) Front Trim - Grime - Small / (R) Front Seat - Grime - Small / Rear Seat - Cut, Crack - Small / Ceiling - Grime - Small</p>	<p><b>Remarks</b> Bonnet - Repair Traces - Yes / (R) Front Door, Molding - Scratch - Medium / (R) Rear Door, Molding - Scratch - Large / (R) Rear Fender, Molding - Dent - Small / (L) Rear Fender, Molding - Scratch - Medium / Bonnet, Headlight - Scratch - Small / (R) Front Fender, Molding - Scratch - Medium</p>
