General Information

Make	Toyota	Model	Wigo
YOM	2025	Odo Meter Reading	10,756
Registration No.	FAS7472	Chassis No.	MHKAA1BC8RJ034179
CC	1.0	Transmission	CVT
Fuel Type	Gas	Type of Body	Hatchback
Colour	Gray

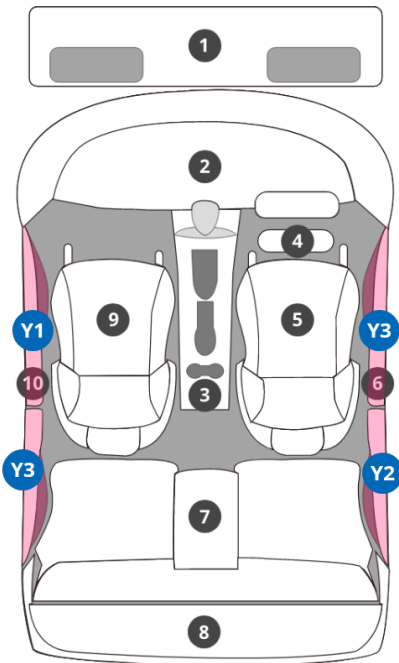
<p>a : Cut, Fray d : Loose, Deformed k : Animal Hair s : Smell t : Cigarette Burns x : Defective y : Stain</p>

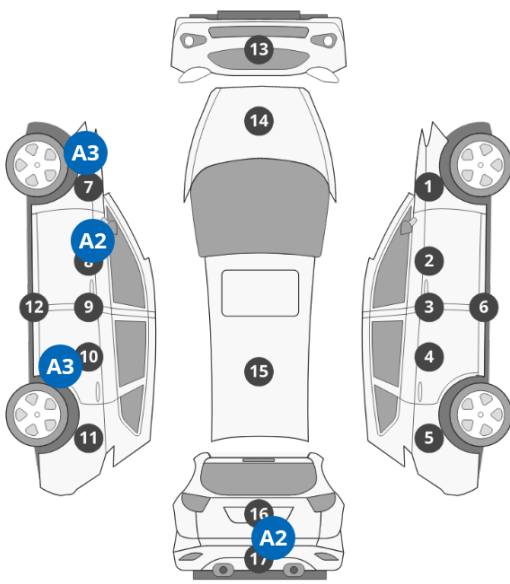
<p>A : Scratch AU : Scratch & Dent B : Modified C : Corrosion G : Stone chip P : Faded S : Rust SC : Rust & Corrosion U : Dent X : Defective Y : Crack, Gap</p>
<p>Remarks (R) Front Trim - Grime - Medium / (R) Rear Trim - Grime - Small / (L) Rear Trim - Grime - Medium / (L) Front Trim - Grime - Minimal</p>	<p>Remarks Trunk Hood, Rear Gate - Scratch - Small / (L) Rear Door, Molding - Scratch - Medium / (L) Front Fender, Molding - Scratch - Medium / (L) Front Door, Molding - Scratch - Small</p>
Frame Evaluation : A	Functional Evaluation : A
<p>Remarks Defects not found</p>	<p>Remarks Defects not found</p>
