General Information

Make	Toyota	Model	Vios
YOM	2023	Odo Meter Reading	38,512
Registration No.	GAP2790	Chassis No.	PA1B18F3XN4197267
CC	1.3	Transmission	CVT
Fuel Type	Gas	Type of Body	Sedan
Colour	Red

Body / Panel Condition

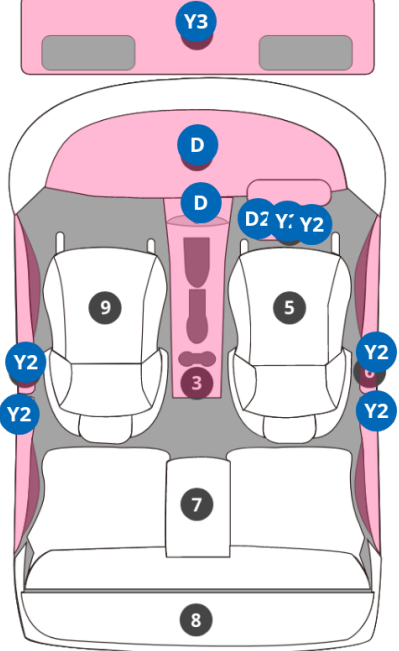
Interior Evaluation : C	Exterior Evaluation : E

<p>a : Cut, Fray d : Loose, Deformed k : Animal Hair s : Smell t : Cigarette Burns x : Defective y : Stain</p>

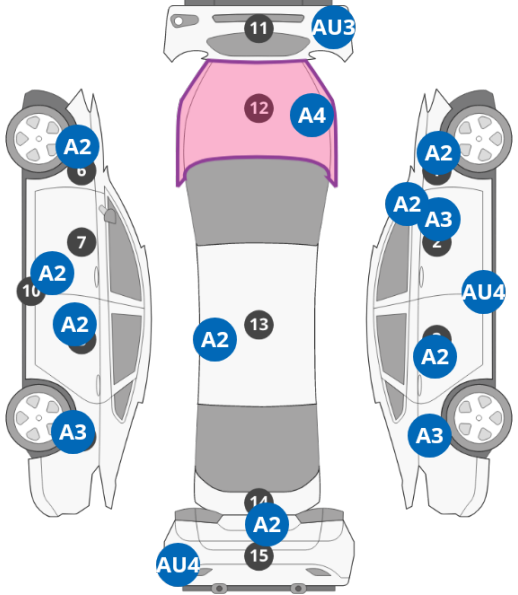
<p>A : Scratch AU : Scratch & Dent B : Modified C : Corrosion G : Stone chip P : Faded S : Rust SC : Rust & Corrosion U : Dent X : Defective Y : Crack, Gap</p>
<p>Remarks (L) Front Trim - Grime - Small / (L) Front Floor Mat - Worked - Small / Console, Switchs, Vents - Traces of Adhesive Tape - Yes / Dashboard - Traces of Adhesive Tape - Yes / Ceiling - Grime - Medium / (L) Rear Trim - Grime - Small / (R) Rear Trim - Grime - Small / Mat Other - Grime - Small / (R) Front Trim - Grime - Small / (R) Front Floor Mat - Grime - Small</p>	<p>Remarks (R) Step - Repair Traces - Yes / Bonnet - Repair Traces - Yes / (L) Rear Fender - Repair Traces - Yes / Overall Exterior - Faded(Color, Gloss) - Yes / Bonnet, Headlight - Repair mark - Yes / (L) Front Fender, Molding - Scratch - Small / (L) Front Door, Molding - Scratch - Small / (L) Rear Fender, Molding - Scratch - Medium / (L) Rear Door, Molding - Scratch - Small / Rear Bumper, Lamps, Panels - Scratch & Dent - Large / Trunk Hood, Rear Gate - Scratch - Small / (R) Rear Fender, Molding - Scratch - Medium / (R) Rear Door, Molding - Scratch - Small / (R) Front Door, Molding - Scratch - Medium / (R) Mirror - Scratch - Small / (R) Step, In-panel, Side Spoiler - Scratch & Dent - Large / (R) Front Fender, Molding - Scratch - Small / Front Bumper, Grille, Lamps - Scratch & Dent - Medium / Bonnet, Headlight - Scratch - Large / Roof - Scratch - Small</p>

<p>Inspector Notes</p>
<p>Possible flooding. Gap at front and rear bumper. Faded paint at bonnet. With warranty booklet, spare tire, jack and seat cover. Without tools. 1 key. With LTO plate.</p>
