General Information

Make	Toyota	Model	Vios
YOM	2025	Odo Meter Reading	9,247
Registration No.	GBF6410	Chassis No.	PA1B18F32R4271786
CC	1.3	Transmission	CVT
Fuel Type	Gas	Type of Body	Sedan
Colour	Blue

Body / Panel Condition

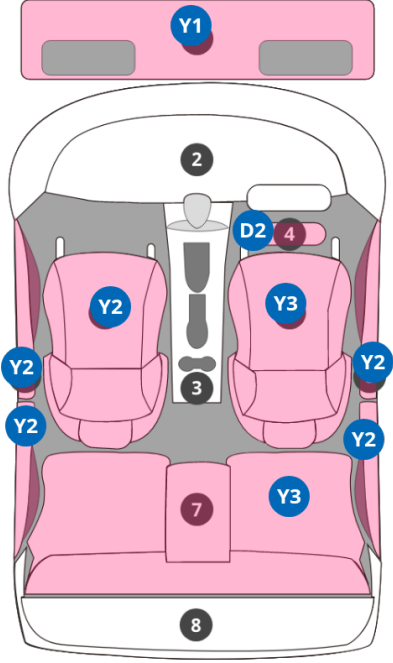
Interior Evaluation : C	Exterior Evaluation : E

<p>a : Cut, Fray d : Loose, Deformed k : Animal Hair s : Smell t : Cigarette Burns x : Defective y : Stain</p>

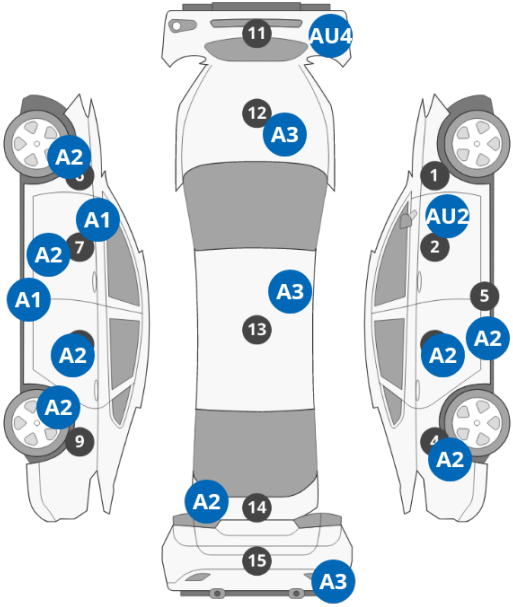
<p>A : Scratch AU : Scratch & Dent B : Modified C : Corrosion G : Stone chip P : Faded S : Rust SC : Rust & Corrosion U : Dent X : Defective Y : Crack, Gap</p>
<p>Remarks (L) Front Trim - Grime - Small / (L) Front Floor Mat - Worked - Small / (L) Front Seat - Grime - Small / Ceiling - Grime - Minimal / (L) Rear Trim - Grime - Small / (R) Rear Trim - Grime - Small / Rear Seat - Grime - Medium / (R) Front Trim - Grime - Small / (R) Front Seat - Grime - Medium</p>	<p>Remarks (L) Rear Fender - Repair Traces - Yes / (R) Front Door, Molding - Scratch & Dent - Small / (R) Step, In-panel, Side Spoiler - Scratch - Small / (R) Rear Door, Molding - Scratch - Small / (R) Rear Fender, Molding - Scratch - Small / Trunk Hood, Rear Gate - Scratch - Small / Rear Bumper, Lamps, Panels - Scratch - Medium / (L) Rear Fender, Molding - Scratch - Small / (L) Rear Door, Molding - Scratch - Small / (L) Step, In-panel, Side Spoiler - Scratch - Minimal / (L) Mirror - Scratch - Minimal / (L) Front Fender, Molding - Scratch - Small / (L) Front Door, Molding - Scratch - Small / Bonnet, Headlight - Scratch - Medium / Front Bumper, Grille, Lamps - Scratch & Dent - Large / Roof - Scratch - Medium</p>
