General Information

Make	Toyota	Model	Vios
YOM	2025	Odo Meter Reading	25,154
Registration No.	JAS7544	Chassis No.	PA1B18F31R4268667
CC	1.3	Transmission	CVT
Fuel Type	Gas	Type of Body	Sedan
Colour	Black

Body / Panel Condition

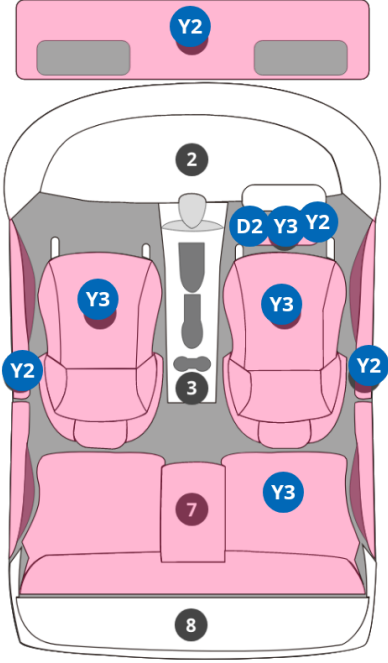
Interior Evaluation : C	Exterior Evaluation : E

<p>a : Cut, Fray d : Loose, Deformed k : Animal Hair s : Smell t : Cigarette Burns x : Defective y : Stain</p>

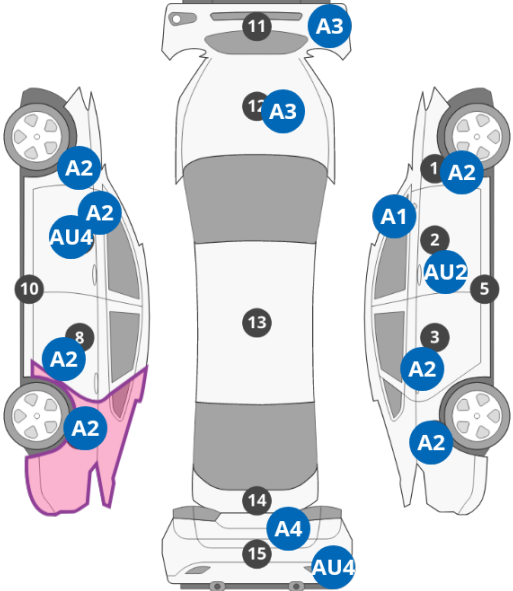
<p>A : Scratch AU : Scratch & Dent B : Modified C : Corrosion G : Stone chip P : Faded S : Rust SC : Rust & Corrosion U : Dent X : Defective Y : Crack, Gap</p>
<p>Remarks (L) Front Seat - Grime - Medium / (L) Front Floor Mat - Worked - Small / (L) Front Trim - Grime - Small / Ceiling - Grime - Small / Rear Seat - Grime - Medium / Mat Other - Grime - Medium / (R) Front Trim - Grime - Small / (R) Front Seat - Grime - Medium / (R) Front Floor Mat - Grime - Small</p>	<p>Remarks Bonnet, Headlight - Scratch - Medium / (L) Front Fender, Molding - Scratch - Small / (L) Mirror - Scratch - Small / (L) Rear Door, Molding - Scratch - Small / (L) Rear Fender, Molding - Scratch - Small / Trunk Hood, Rear Gate - Scratch - Large / Rear Bumper, Lamps, Panels - Scratch & Dent - Large / (R) Rear Fender, Molding - Scratch - Small / (R) Rear Door, Molding - Scratch - Small / (R) Front Door, Molding - Scratch & Dent - Small / (R) Mirror - Scratch - Minimal / (R) Front Fender, Molding - Scratch - Small / Front Bumper, Grille, Lamps - Scratch - Medium / (L) Front Door, Molding - Scratch & Dent - Large / (L) Rear Wheel, Cover - Cap Missing - Yes</p>
