General Information

Make	Toyota	Model	Hilux Tamaraw
YOM	2025	Odo Meter Reading	6,375
Registration No.	NJC3573	Chassis No.	PAHAD9DA7S1627281
CC	2.4	Transmission	A/T
Fuel Type	Diesel	Type of Body	Dropside
Colour	Black

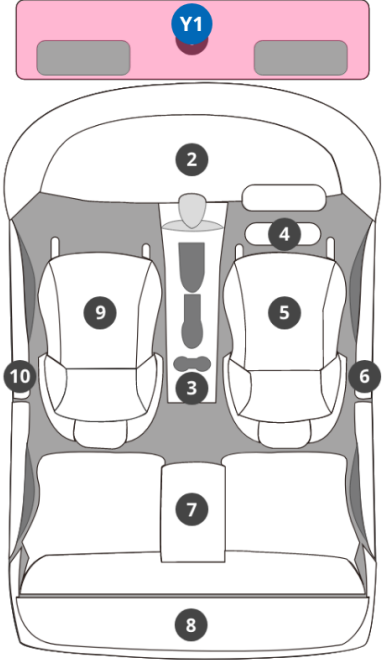
Interior Evaluation : A	Exterior Evaluation : D

<p>a : Cut, Fray d : Loose, Deformed k : Animal Hair s : Smell t : Cigarette Burns x : Defective y : Stain</p>

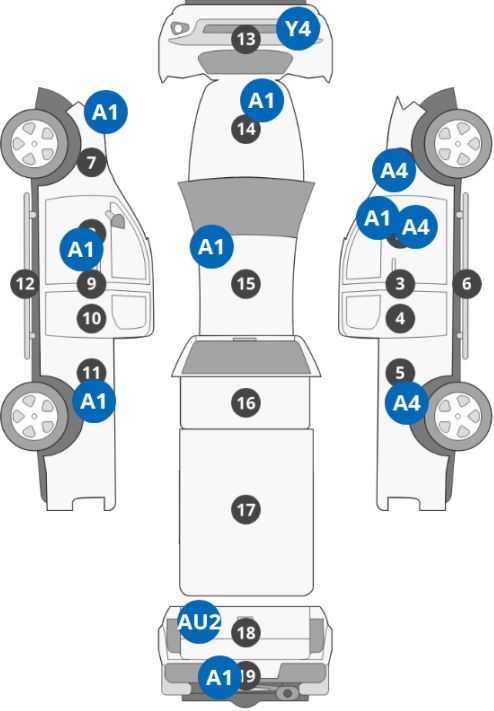
<p>A : Scratch AU : Scratch & Dent B : Modified C : Corrosion G : Stone chip P : Faded S : Rust SC : Rust & Corrosion U : Dent X : Defective Y : Crack, Gap</p>
Remarks Ceiling - Grime - Minimal	Remarks (R) Front Fender, Molding - Scratch - Large / (R) Mirror - Scratch - Minimal / (R) Front Door, Molding - Scratch - Large / (R) Guard Frame - Scratch - Large / (L) Side Gate - Scratch - Minimal / (L) Front Door, Molding - Scratch - Minimal / Roof - Scratch - Minimal / (L) Front Fender, Molding - Scratch - Minimal / Bonnet, Headlight - Scratch - Minimal / Front Bumper, Grille, Lamps - Crack, Gap - Large / Rear Gate - Scratch & Dent - Small / Rear Bumper, Lamps, Panels - Scratch - Minimal
Frame Evaluation : A	Functional Evaluation : B

Inspector Notes
No Lto plate, with warranty booklet, with spare, with jack and tools, Crack headlight, battery weak
