General Information

Body / Panel Condition

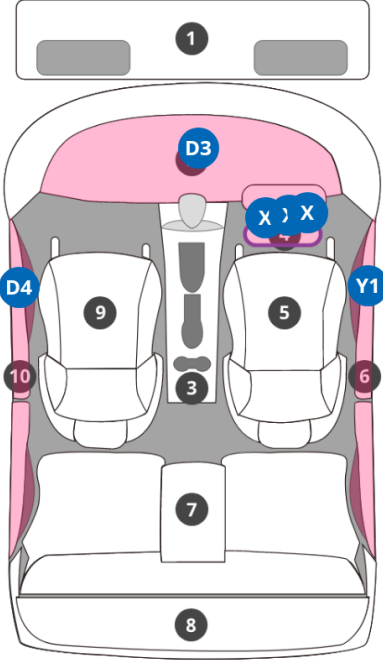
Interior Evaluation : C	Exterior Evaluation : D

<p>a : Cut, Fray d : Loose, Deformed k : Animal Hair s : Smell t : Cigarette Burns x : Defective y : Stain</p>

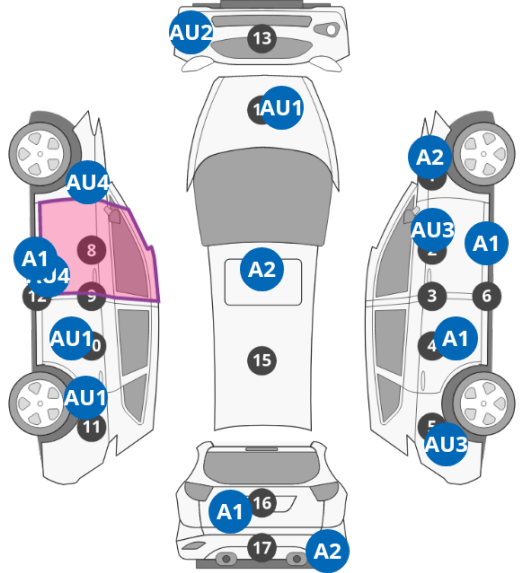
<p>A : Scratch AU : Scratch & Dent B : Modified C : Corrosion G : Stone chip P : Faded S : Rust SC : Rust & Corrosion U : Dent X : Defective Y : Crack, Gap</p>
<p>Remarks Dashboard - Loose, Deformed - Medium / (L) Front Trim - Loose, Deformed - Large / (R) Front Floor Mat - Missing - Yes / (L) Front Floor Mat - Missing - Yes / Mat Other - Missing - Yes / (R) Front Trim - Grime - Minimal</p>	<p>Remarks (L) Front Door - Repair Traces - Yes / (R) Front Fender, Molding - Scratch - Small / (R) Front Door, Molding - Scratch & Dent - Medium / (R) Rear Door, Molding - Scratch - Minimal / (R) Rear Fender, Molding - Scratch & Dent - Medium / Rear Bumper, Lamps, Panels - Scratch - Small / Trunk Hood, Rear Gate - Scratch - Minimal / (L) Rear Fender, Molding - Scratch & Dent - Minimal / (L) Rear Door, Molding - Scratch & Dent - Minimal / (L) Front Door, Molding - Scratch & Dent - Large / (L) Front Door, Molding - Repair mark - Yes / (L) Front Fender, Molding - Scratch & Dent - Large / Front Bumper, Grille, Lamps - Scratch & Dent - Small / Bonnet, Headlight - Scratch & Dent - Minimal / Roof - Scratch - Small / (L) Step, In-panel, Side Spoiler - Scratch - Minimal / (R) Step, In-panel, Side Spoiler - Scratch - Minimal</p>
