## General Information

| Make | Toyota | Model | Vios |
| Registration No. | DBB1545 | Chassis No. | PA1B18F3XL4121688 |

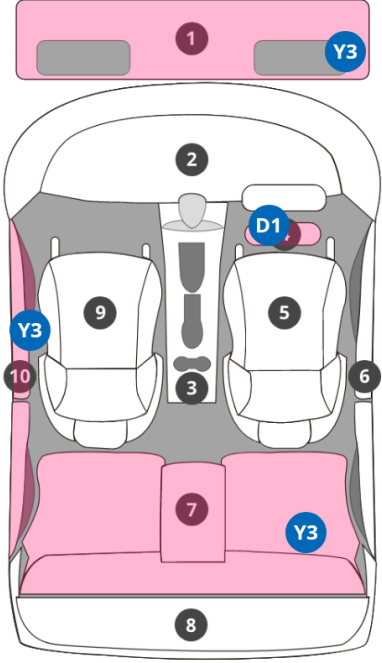
| Interior Evaluation : <b>B</b> | Exterior Evaluation : <b>D</b> |
|---|---|
| <p><b>Remarks</b><br/>Carpet - Worked - Minimal / Ceiling - Grime - Medium / (L) Front Trim - Grime - Medium / Rear Seat - Grime - Medium</p> | <p><b>Remarks</b><br/>(R) Front Fender, Molding - Repair mark - Difference in Color / (R) Front Fender, Molding - Dent - Medium / (R) Front Door, Molding - Scratch &amp; Dent - Small / (R) Rear Fender, Molding - Dent - Small / Rear Bumper, Lamps, Panels - Repair mark - Difference in Color / Trunk Hood, Rear Gate - Dent - Medium / Rear Bumper, Lamps, Panels - Scratch &amp; Dent - Medium / (L) Rear Fender, Molding - Scratch &amp; Dent - Small / Roof - Dent - Minimal / (L) Front Fender, Molding - Dent - Small / Member (Bolted) - Dent - Yes / Front Bumper, Grille, Lamps - Scratch - Medium / Bonnet, Headlight - Scratch &amp; Dent - Medium</p> |
