General Information

Make	Toyota	Model	Veloz
YOM	2024	Odo Meter Reading	52,702
Registration No.	NHH5252	Chassis No.	MHFAB1BY03085428
CC	1.5	Transmission	CVT
Fuel Type	Gas	Type of Body	SUV
Colour	Red

Body / Panel Condition

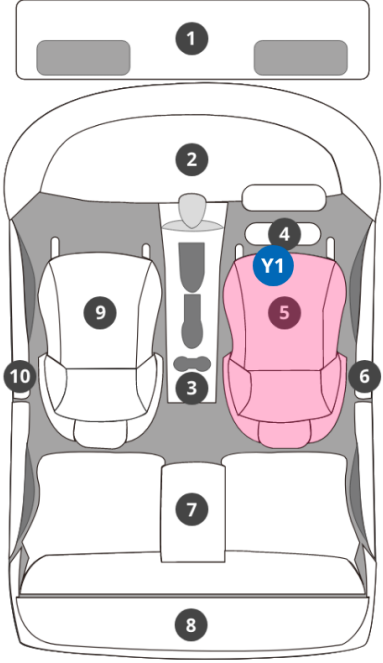
<p>a : Cut, Fray d : Loose, Deformed k : Animal Hair s : Smell t : Cigarette Burns x : Defective y : Stain</p>

<p>A : Scratch AU : Scratch & Dent B : Modified C : Corrosion G : Stone chip P : Faded S : Rust SC : Rust & Corrosion U : Dent X : Defective Y : Crack, Gap</p>
Remarks (R) Front Seat - Grime - Minimal	Remarks (R) Front Fender, Molding - Scratch - Minimal / (R) Front Door, Molding - Scratch & Dent - Minimal / (R) Rear Door, Molding - Scratch - Minimal / (R) Rear Fender, Molding - Scratch - Minimal / Trunk Hood, Rear Gate - Scratch - Small / Rear Bumper, Lamps, Panels - Scratch - Minimal / (L) Rear Door, Molding - Scratch & Dent - Minimal / (L) Mirror - Scratch - Minimal / (L) Front Door, Molding - Scratch - Minimal / (L) Front Fender, Molding - Scratch - Minimal / Front Bumper, Grille, Lamps - Scratch - Medium / Bonnet, Headlight - Scratch - Minimal

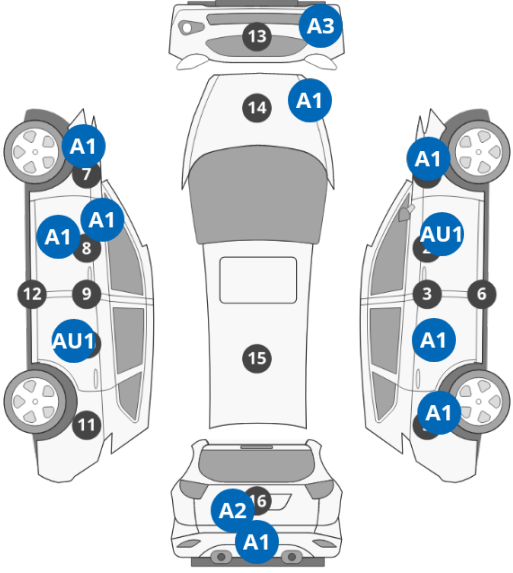
Inspector Notes
With Lto plate, with warranty booklet, with spare tire and jack, 2keys, no tools, scratches on headlights and taillights
