General Information

Make	Audi	Model	A1
YOM	2018	Odo Meter Reading	46,999
Registration No.	NEM8735	Chassis No.	WAUZZZZ8X1JB019257
CC	1.4	Transmission	A/T
Fuel Type	Gas	Type of Body	Hatchback
Colour	White

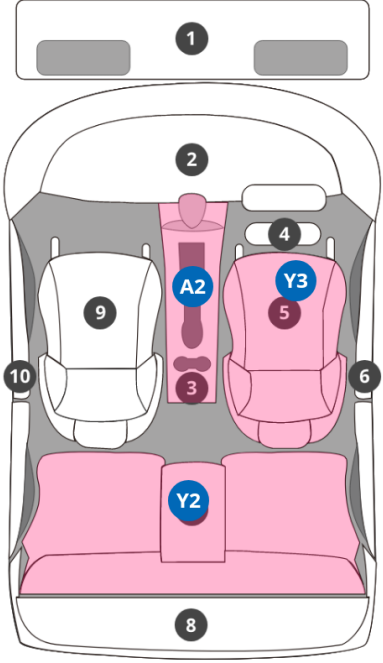
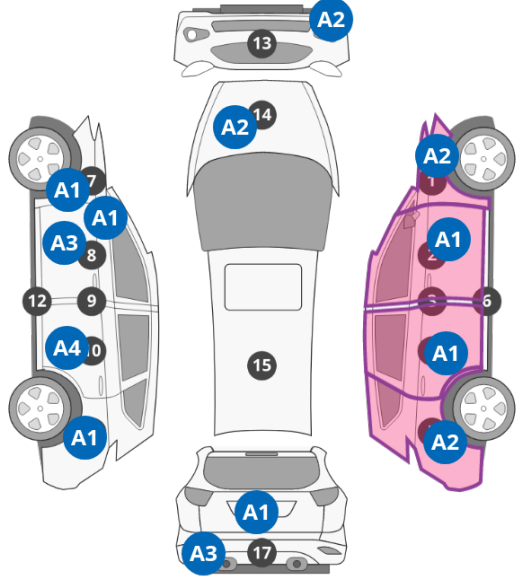
Interior Evaluation :	B	Exterior Evaluation :	D

<p>a : Cut, Fray d : Loose, Deformed k : Animal Hair s : Smell t : Cigarette Burns x : Defective y : Stain</p>		<p>A : Scratch AU : Scratch & Dent B : Modified C : Corrosion G : Stone chip P : Faded S : Rust SC : Rust & Corrosion U : Dent X : Defective Y : Crack, Gap</p>	
<p>Remarks (R) Front Seat - Grime - Medium / Rear Seat - Grime - Small / Knobs - Worn, Peel, Crack - Small</p>		<p>Remarks Overall Exterior - Full Re-Paint in same color - Yes / (R) Front Fender, Molding - Repair mark - Yes / (R) Front Door, Molding - Repair mark - Yes / (R) Rear Door, Molding - Repair mark - Yes / (R) Rear Fender, Molding - Repair mark - Yes / (R) Front Fender, Molding - Scratch - Small / (R) Front Door, Molding - Scratch - Minimal / (R) Rear Door, Molding - Scratch - Minimal / (R) Rear Fender, Molding - Scratch - Small / Rear Bumper, Lamps, Panels - Scratch - Medium / Trunk Hood, Rear Gate - Scratch - Minimal / (L) Rear Fender, Molding - Scratch - Minimal / (L) Rear Door, Molding - Scratch - Large / (L) Front Door, Molding - Scratch - Medium / (L) Mirror - Scratch - Minimal / (L) Front Fender, Molding - Scratch - Minimal / Bonnet, Headlight - Scratch - Small / Front Bumper, Grille, Lamps - Scratch - Small</p>
