General Information

Make	Lexus	Model	IS 350
YOM	2014	Odo Meter Reading	66,462
Registration No.	WNQ543	Chassis No.	JTHBE5D2105008497
CC	3.5	Transmission	A/T
Fuel Type	Gas	Type of Body	Sedan
Colour	Blue

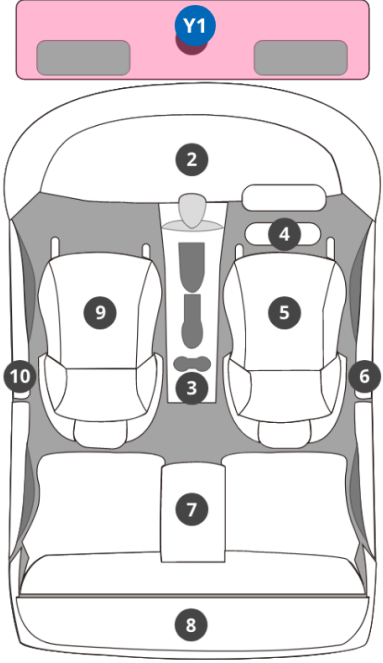
Interior Evaluation : A	Exterior Evaluation : E

<p>a : Cut, Fray d : Loose, Deformed k : Animal Hair s : Smell t : Cigarette Burns x : Defective y : Stain</p>

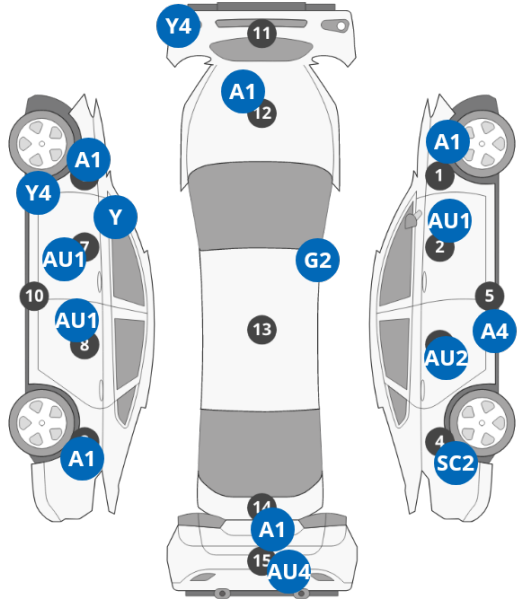
<p>A : Scratch AU : Scratch & Dent B : Modified C : Corrosion G : Stone chip P : Faded S : Rust SC : Rust & Corrosion U : Dent X : Defective Y : Crack, Gap</p>
Remarks Ceiling - Grime - Minimal	Remarks (R) Front Fender, Molding - Scratch - Minimal / (R) Front Door, Molding - Scratch & Dent - Minimal / (R) Rear Door, Molding - Scratch & Dent - Small / (R) Step, In-panel, Side Spoiler - Scratch - Large / (R) Rear Fender, Molding - Rust, Corrosion - Small / Trunk Hood, Rear Gate - Scratch - Minimal / Rear Bumper, Lamps, Panels - Scratch & Dent - Large / (L) Rear Fender, Molding - Scratch - Minimal / (L) Rear Door, Molding - Scratch & Dent - Minimal / (L) Front Door, Molding - Scratch & Dent - Minimal / (L) Mirror - Crack - Cracks / (L) Step, In-panel, Side Spoiler - Crack, Gap - Large / (L) Front Fender, Molding - Scratch - Minimal / Bonnet, Headlight - Scratch - Minimal / Front Bumper, Grille, Lamps - Crack, Gap - Large / Front Windshield - Scratch, Stone chip - Small
